Foreshore Management Plan for the Swan River Estuary in the Western Suburbs of Perth

For the Western Suburbs Regional Organisation of Councils
(WESROC)

Seashore Engineering Pty Ltd
25 May 2016

Report SE018-01-Rev0

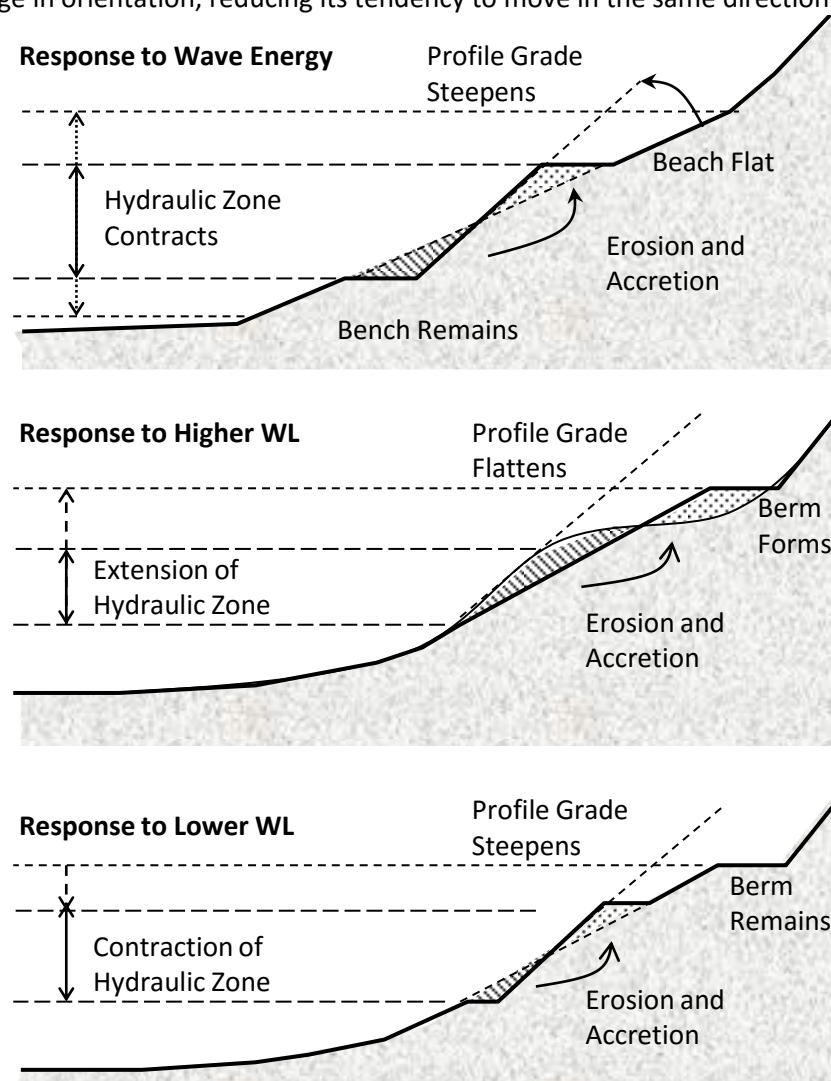
Figure 2-7: Common Profile Adjustments to Changing Conditions

Cyclic behaviour is also common through alongshore transport on a seasonal basis, where the foreshore position responds to changes in wind-wave direction. The overall behaviour is affected by any compartmentalisation of the foreshore, as sediment pushed towards any barrier to transport will cause the foreshore to change in orientation, reducing its tendency to move in the same direction.

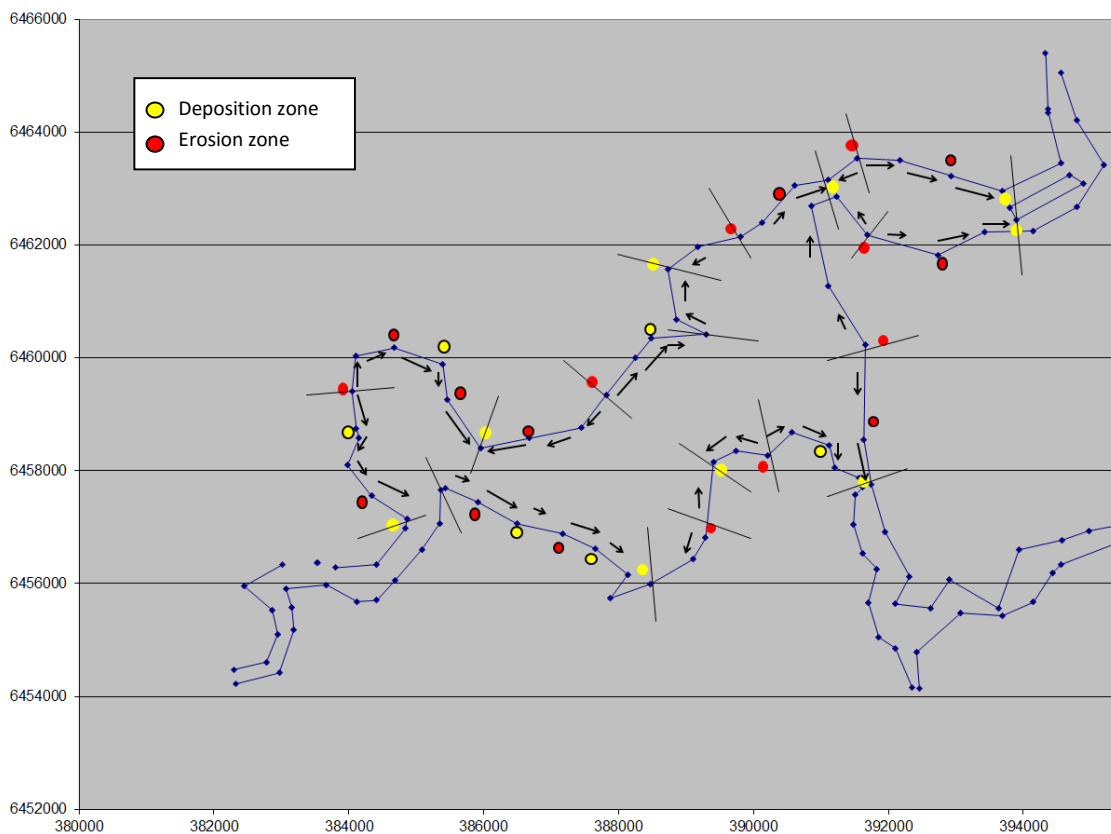
Figure 2-9: Potential Erosion and Deposition Zones

Within the lower Swan River estuary, the available water surface length over which wind waves can develop (fetch) varies systematically along the shore, producing changes to incident wave conditions and corresponding differences in prevailing sediment transport bias, according to foreshore orientation. Analysis of the wind directional distribution, available fetches and foreshore orientation has been undertaken, to evaluate the areas in which potential sediment transport is likely to converge, promoting accretion; or diverge, promoting erosion (Figure 2-9). The analysis of potential erosion and deposition zones does not take into account the shore type or effects of currents, which are particularly important at points of constriction. Zones at which prevailing sediment transport paths diverge or converge are noted by an un-circled dot. Circled dots identify areas where potential sediment transport changes in magnitude, which may cause a tendency for erosion (increasing transport rate) or accretion (decreasing transport rate).

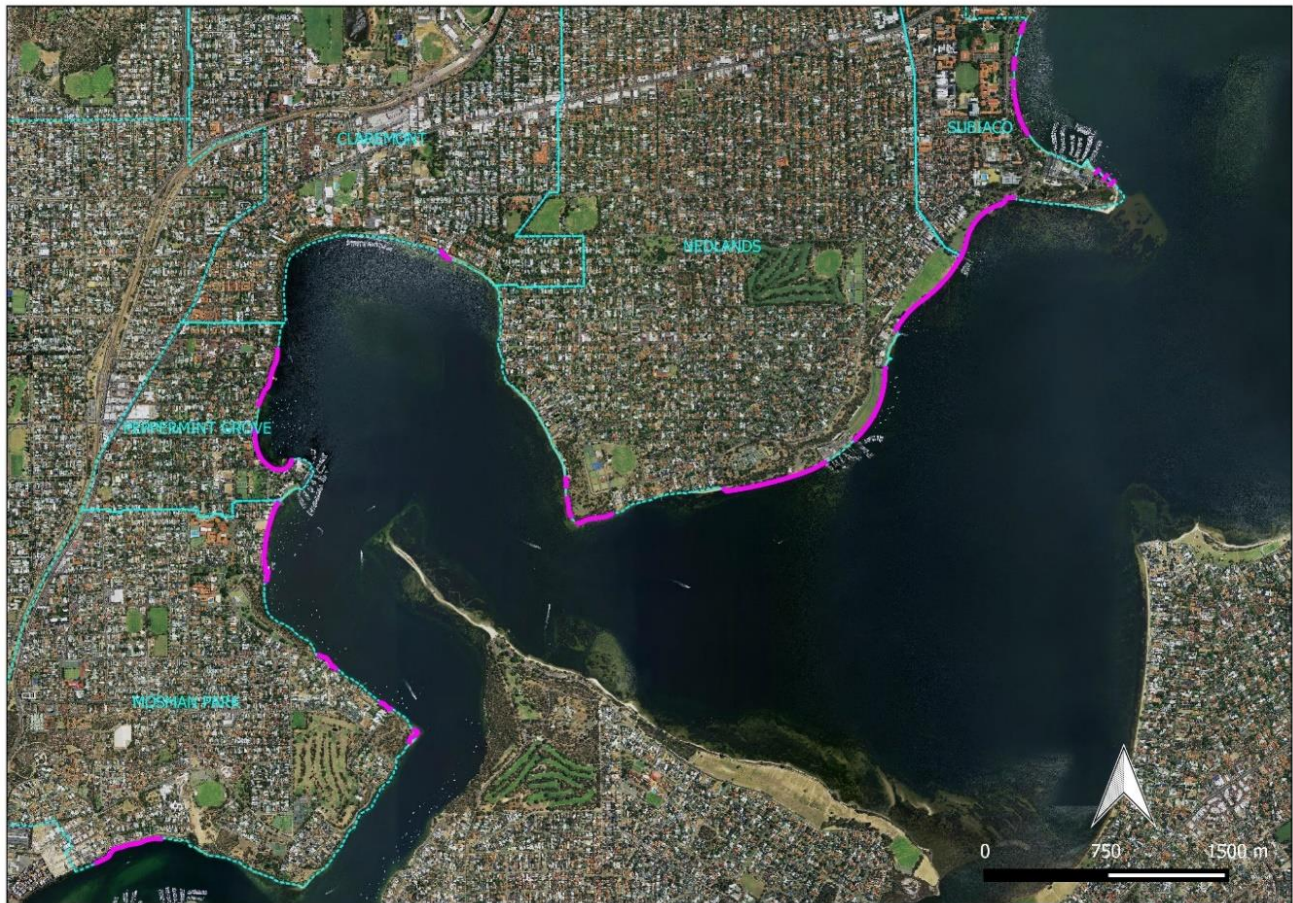
Figure 2-13: Publicly-owned Structures

Hard erosion mitigation structures within the hydraulic zone of the WESROC foreshore are shown in Figure 2-13. These are the structures on public land, excluding yacht clubs and private property.

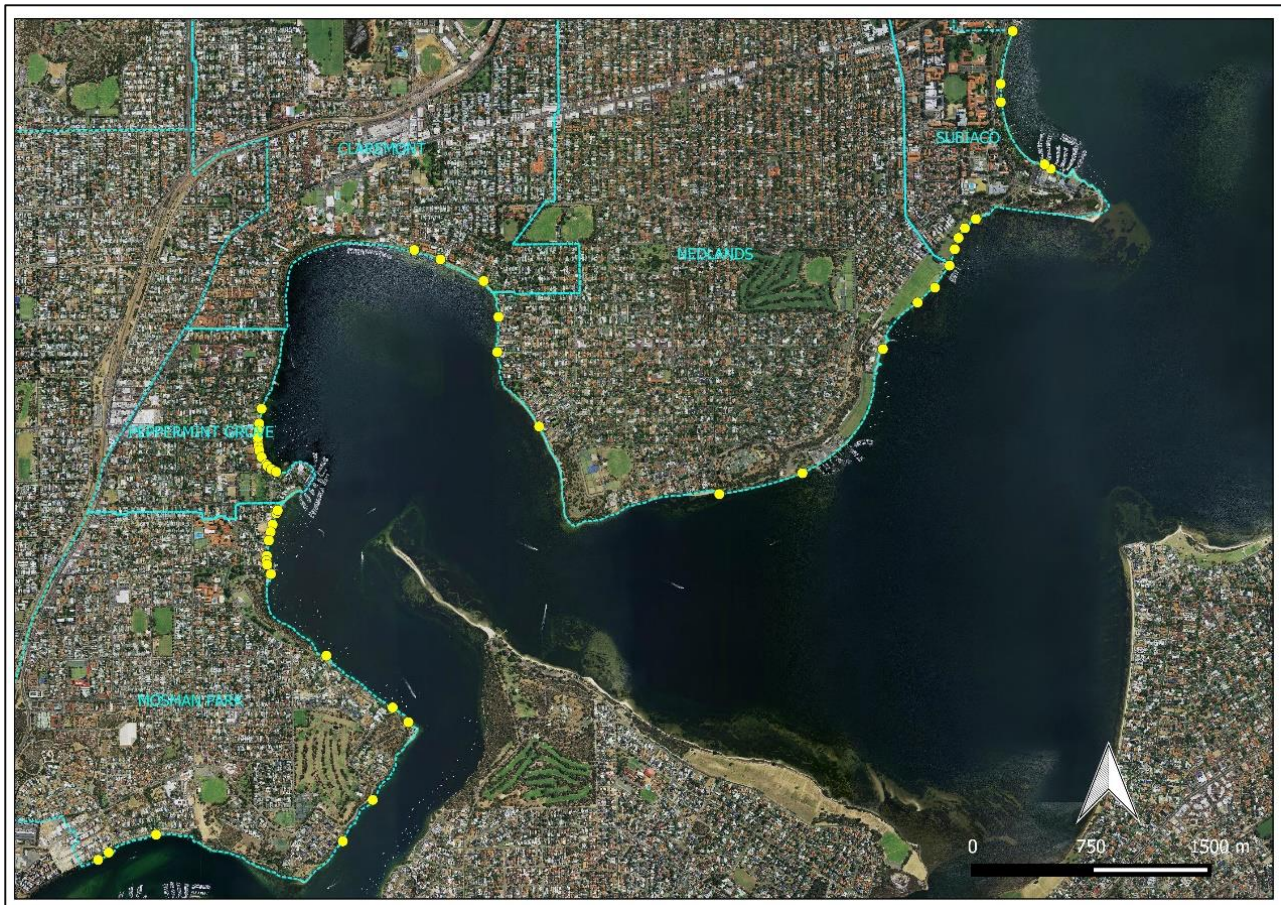
Figure 2-14: Drains

Formalised stormwater drainage to the Swan River has changed over time, with a number of large drains including northern Matilda Bay, JH Abrahams Reserve, Jetty Road (Claremont) and Keane Street as well as smaller drains (Figure 2-14). Formation of sand bars at JH Abrahams Reserve and Jetty Road Claremont contribute to water quality concerns and require active sediment management. Some drains have insufficient capacity for high flows (e.g. southern Mosman Bay) with overbank flow or have headwalls or scour aprons that exacerbate erosion of adjacent banks (e.g. northern Freshwater Bay).

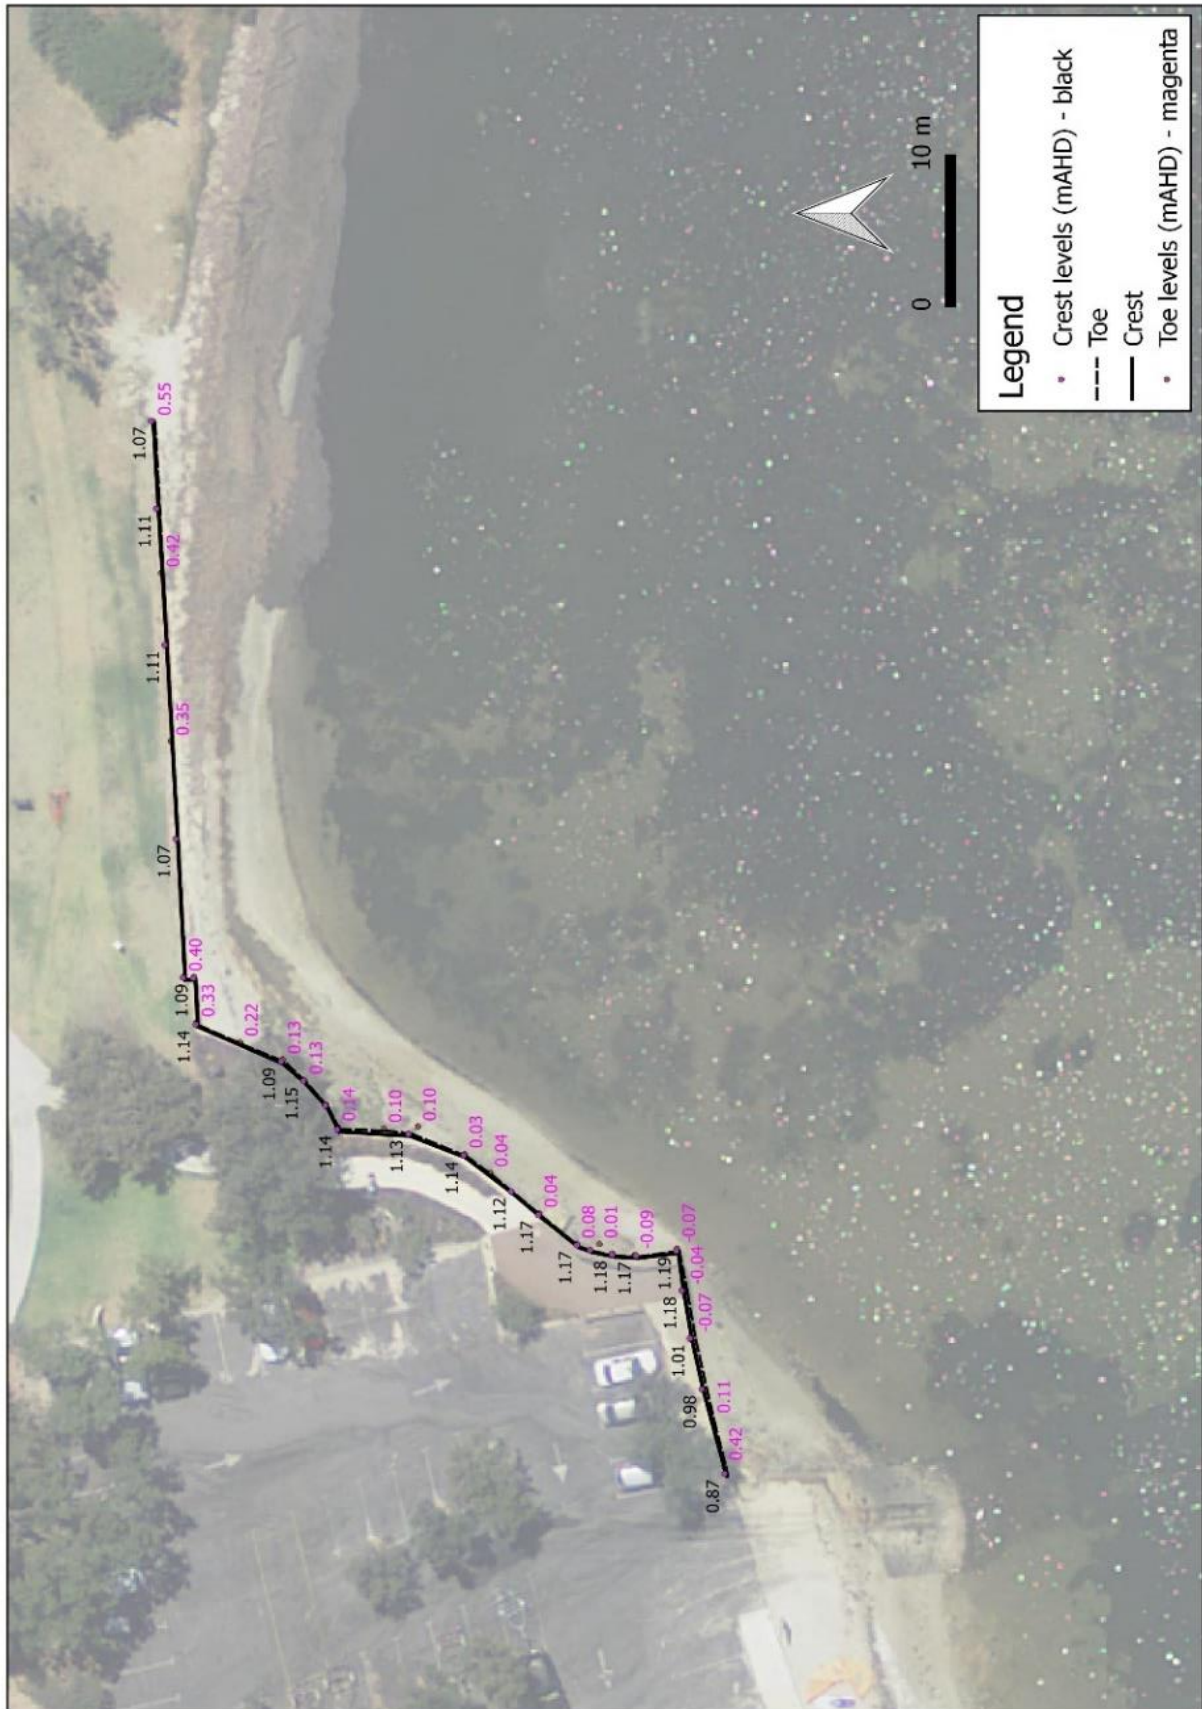
Figure 6-6: Qantas Ramp Car Park Walling (SRCra05.B01) Levels - January 2015 (on 2014 image)

The walling at the boat ramp car park (SRCra05.B01) was constructed with insufficient embedment. Works were undertaken (2006-2007) to infill concrete under the toe of the walling and to shift the eastern extent of the walling 2.5m landward after it failed.

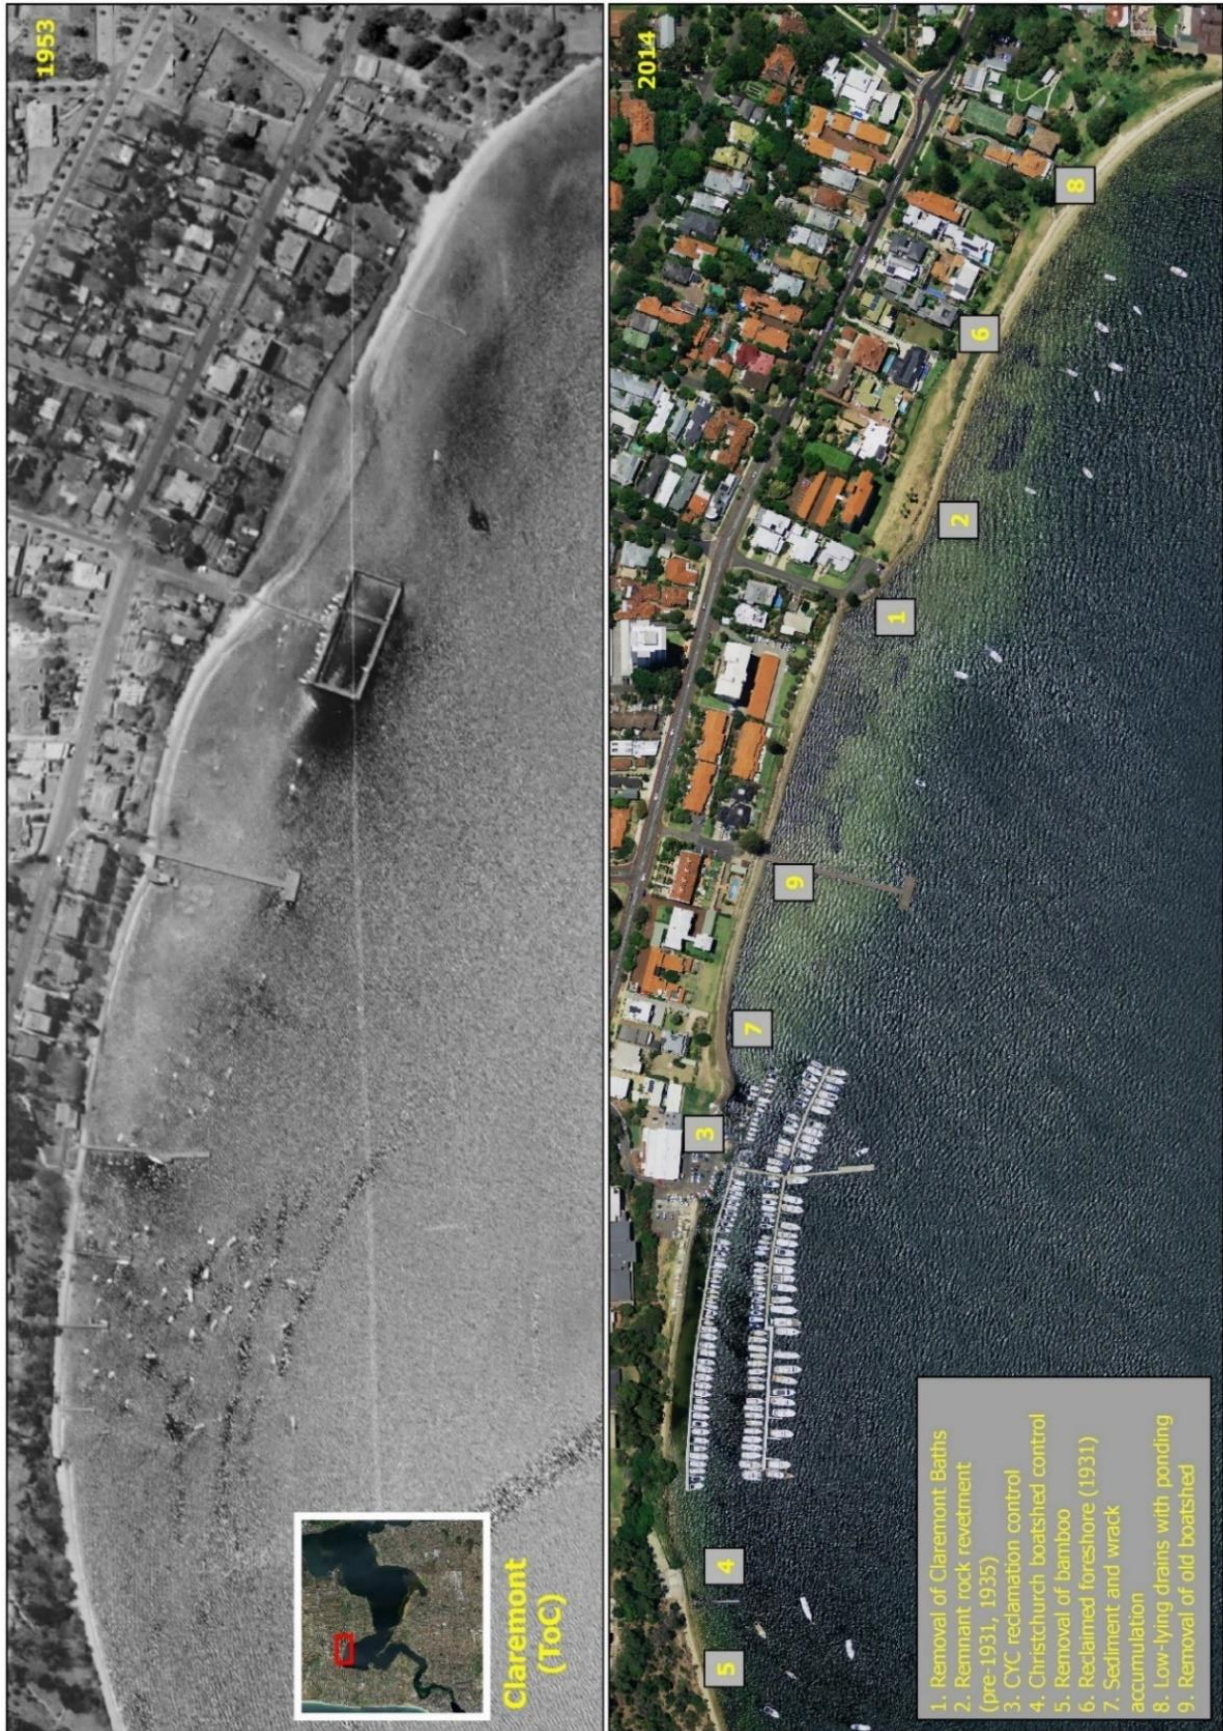
Figure 8-2: Some issues and modifications for the main recreational area of Town of Claremont

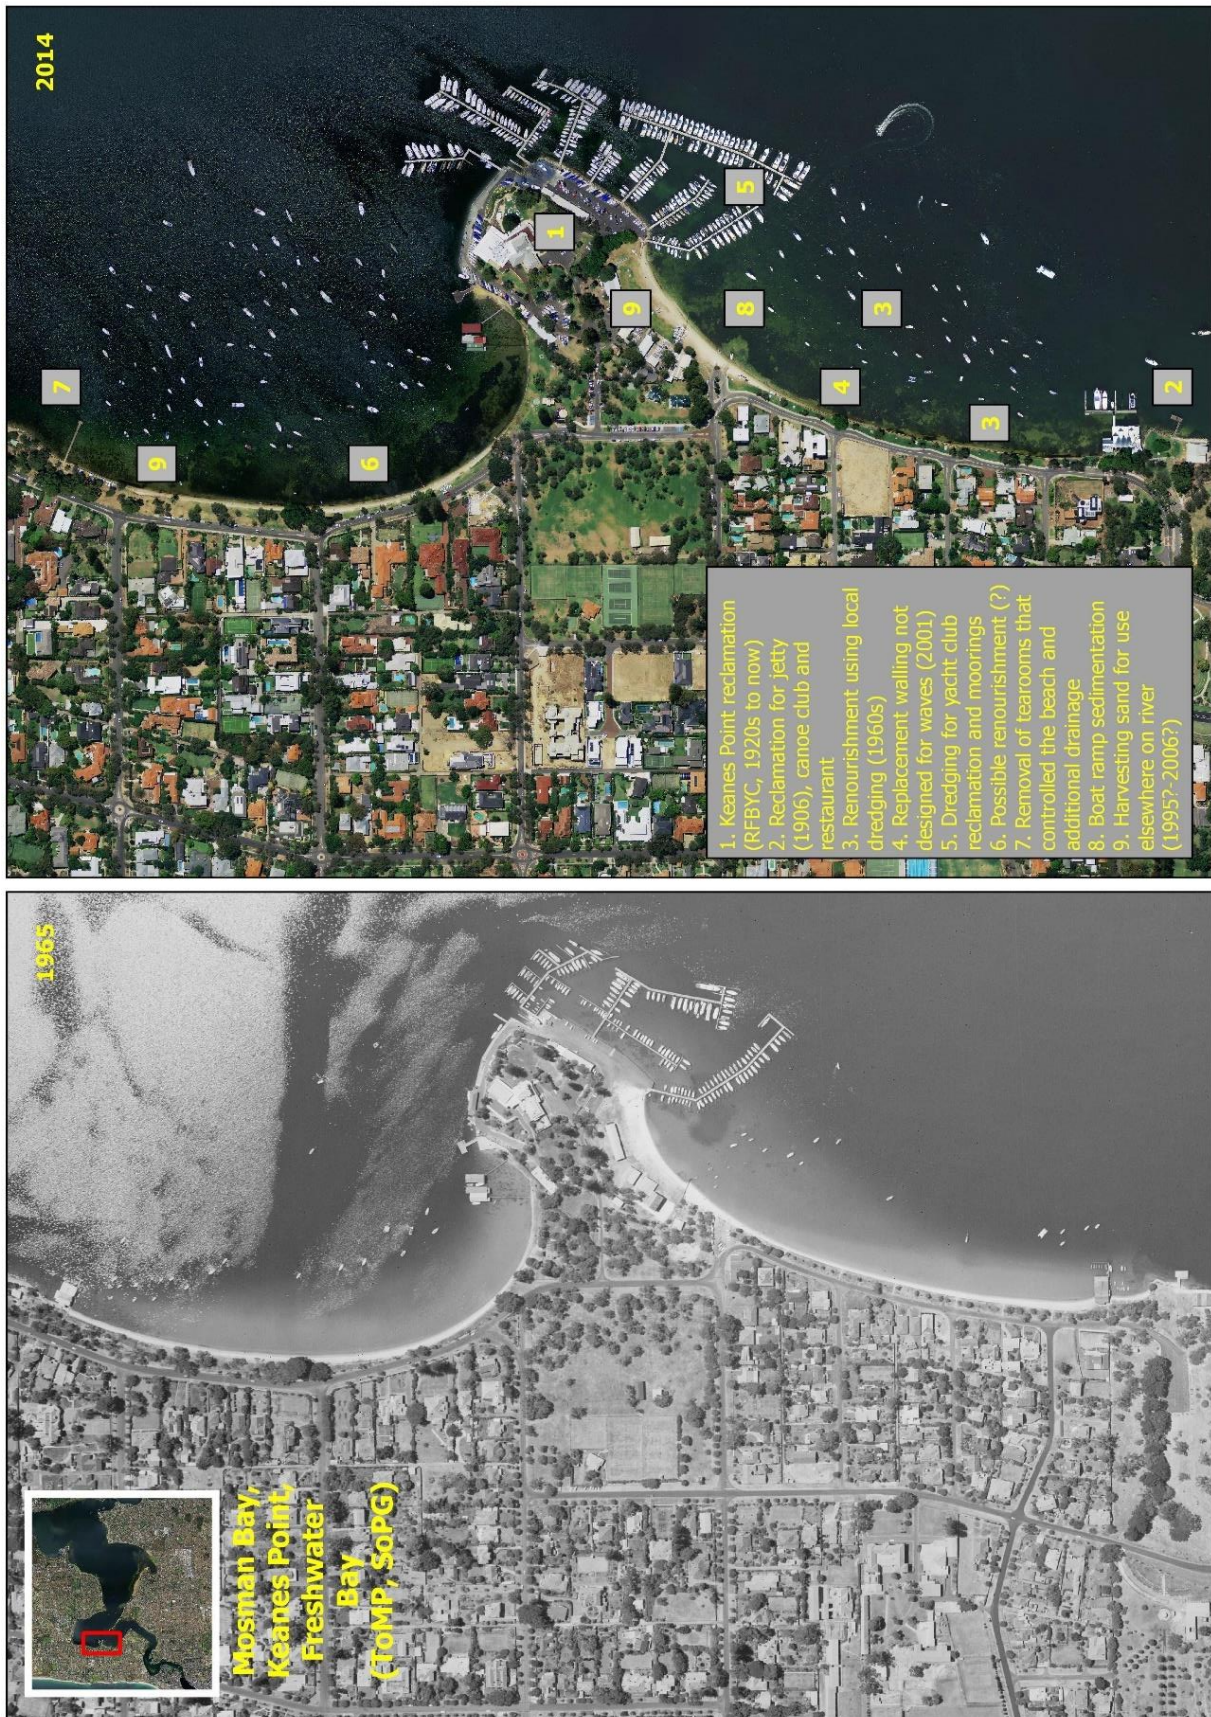
Figure 9-2: Some issues and modifications for Freshwater Bay, Keanes Point and Mosman Bay (south of boat ramp is Town of Mosman Park)

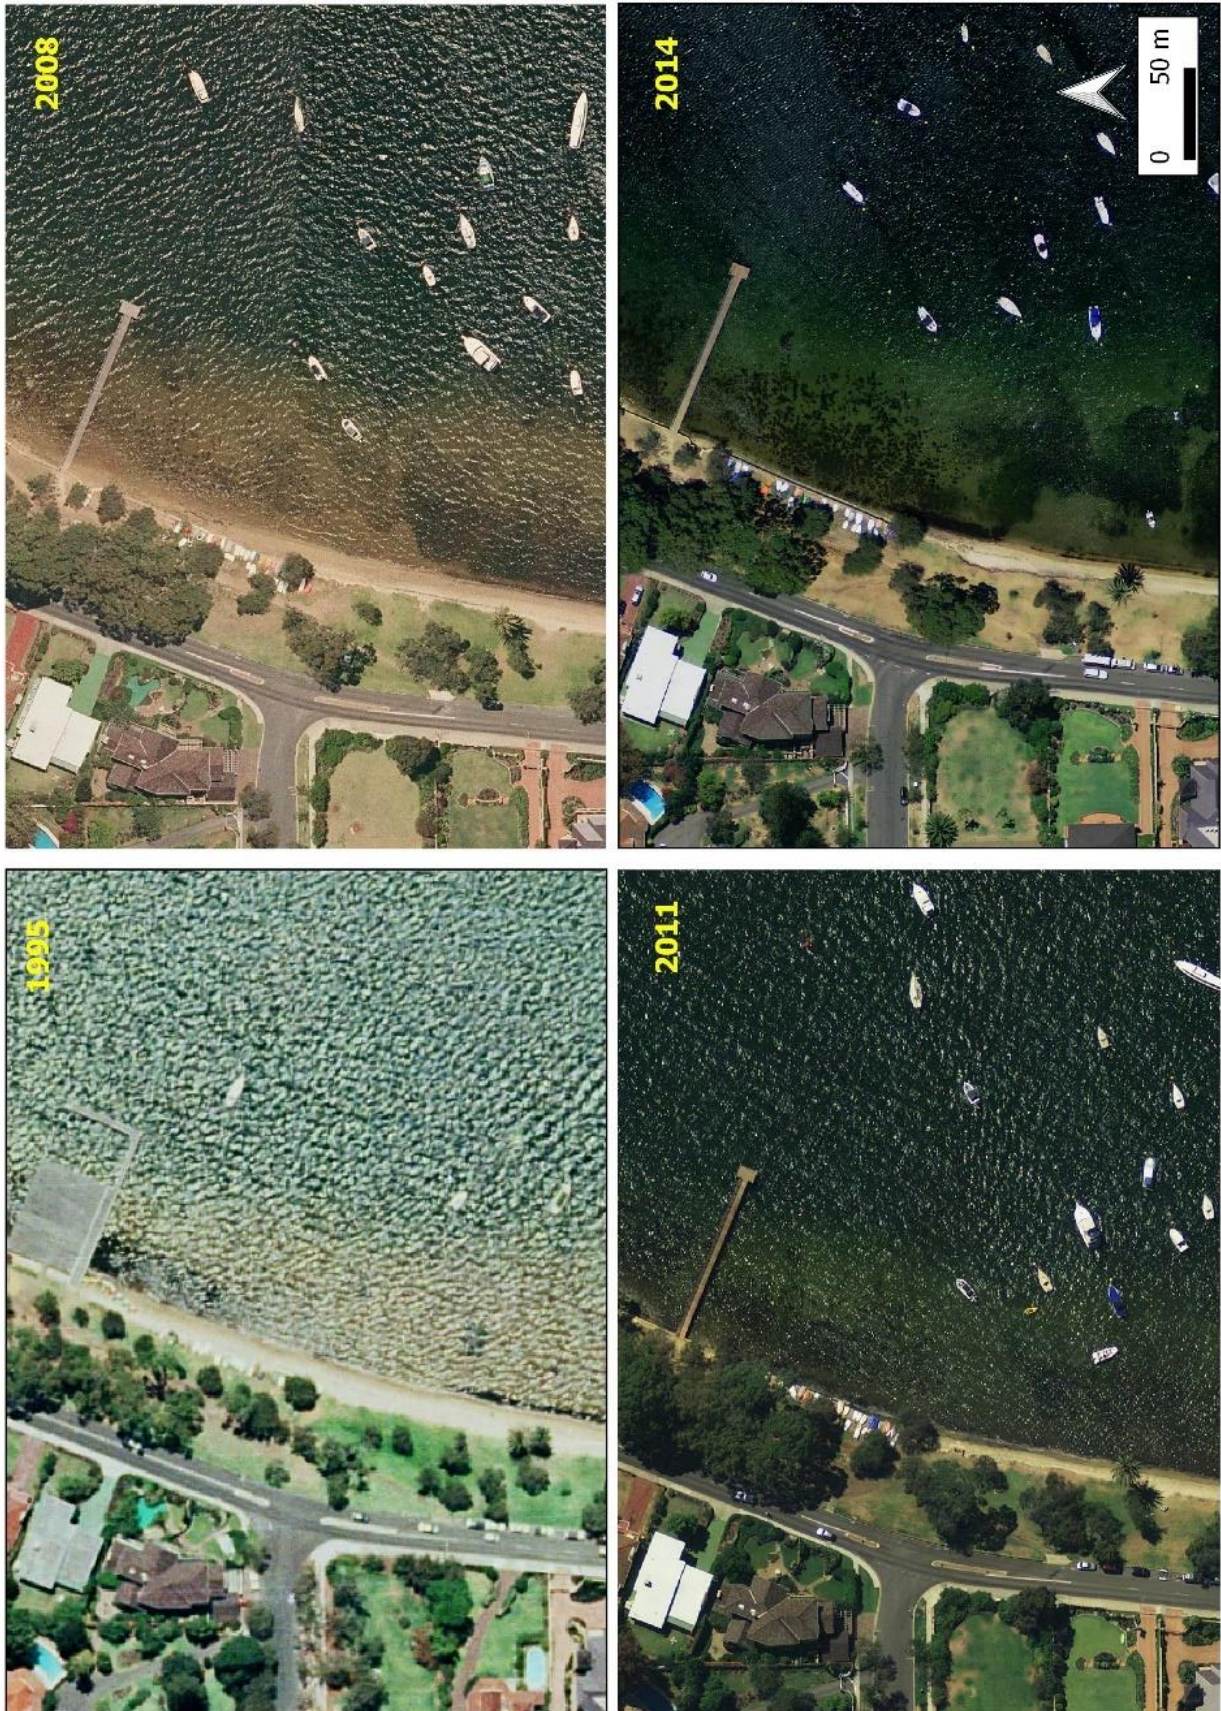
**Figure 9-7: SRPep01/SRPep02 Foreshore Modifications from 1995-2014
(Source: Landgate)**

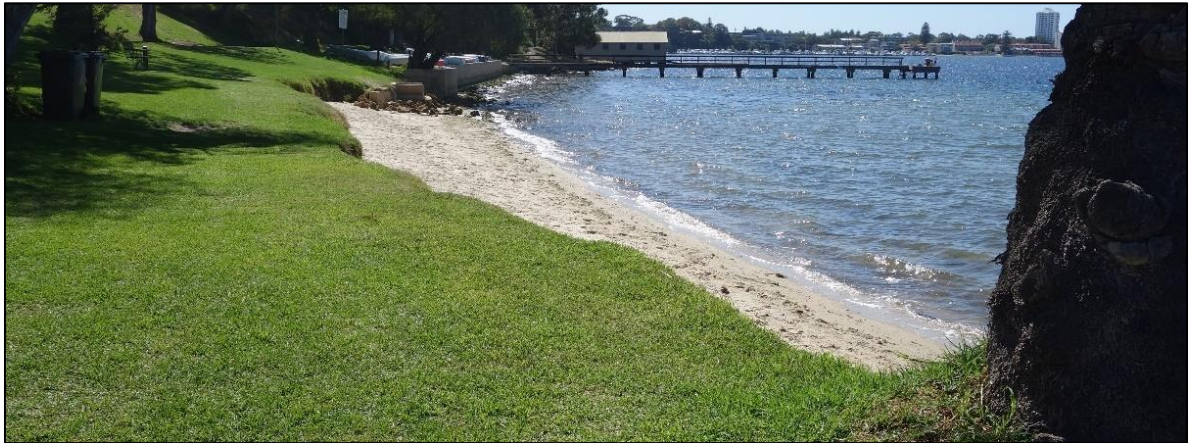
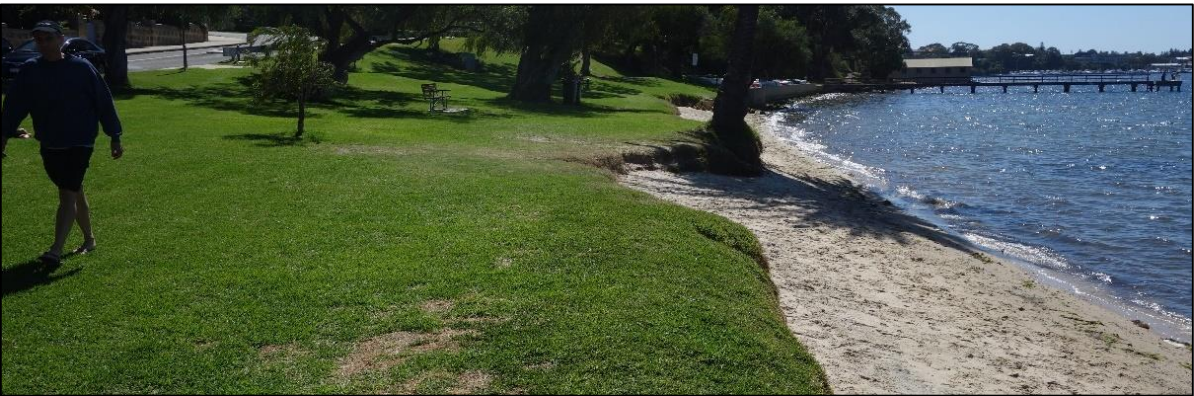
Figure 9-8: Retreat in northern SRPep02 (proximate to Leake St) – 16 April 2015
Base image is broader retreat

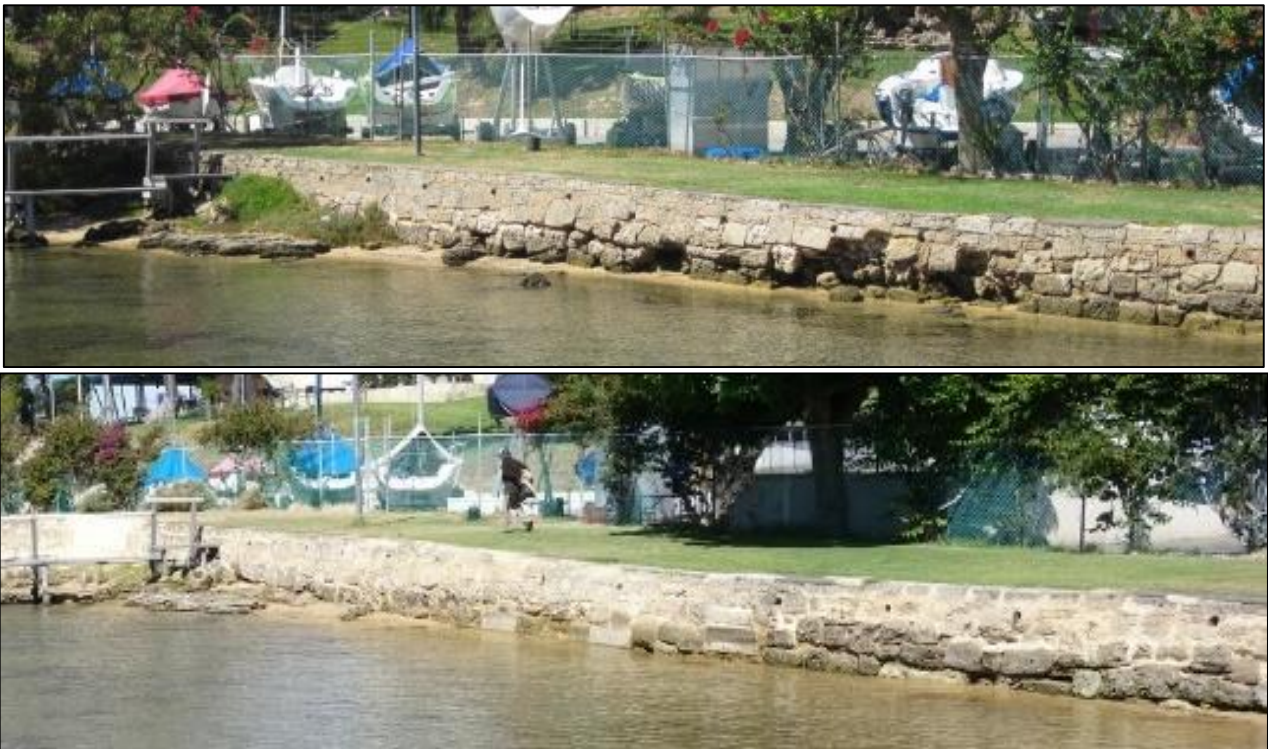
Figure 9-11: Example of SRPep02 Walling Failure and Maintenance (2010 Top, 2014 Base)

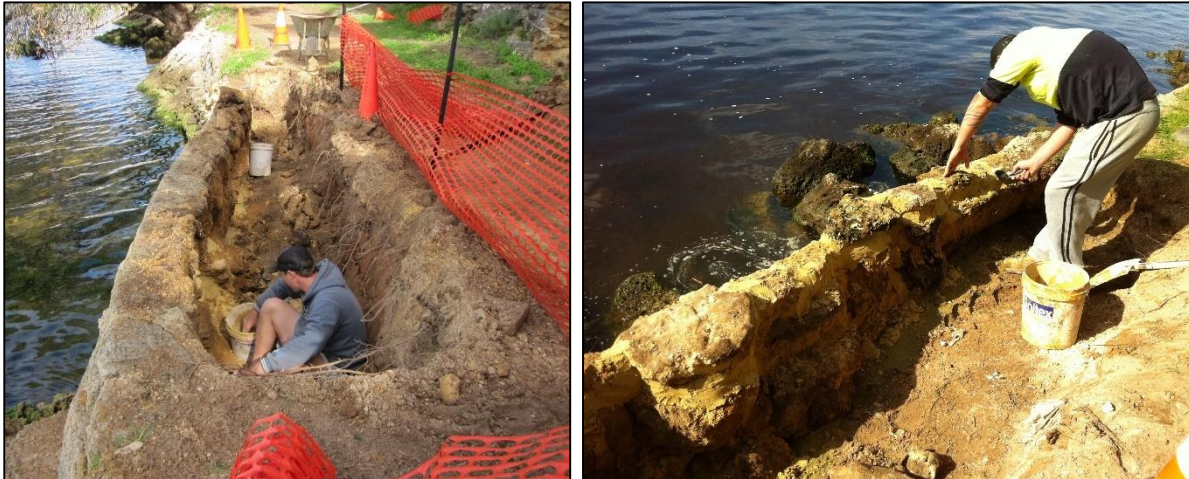
Figure 9-16: Partial Wall Reconstruction SRPep01 (August 2011, SoPG)

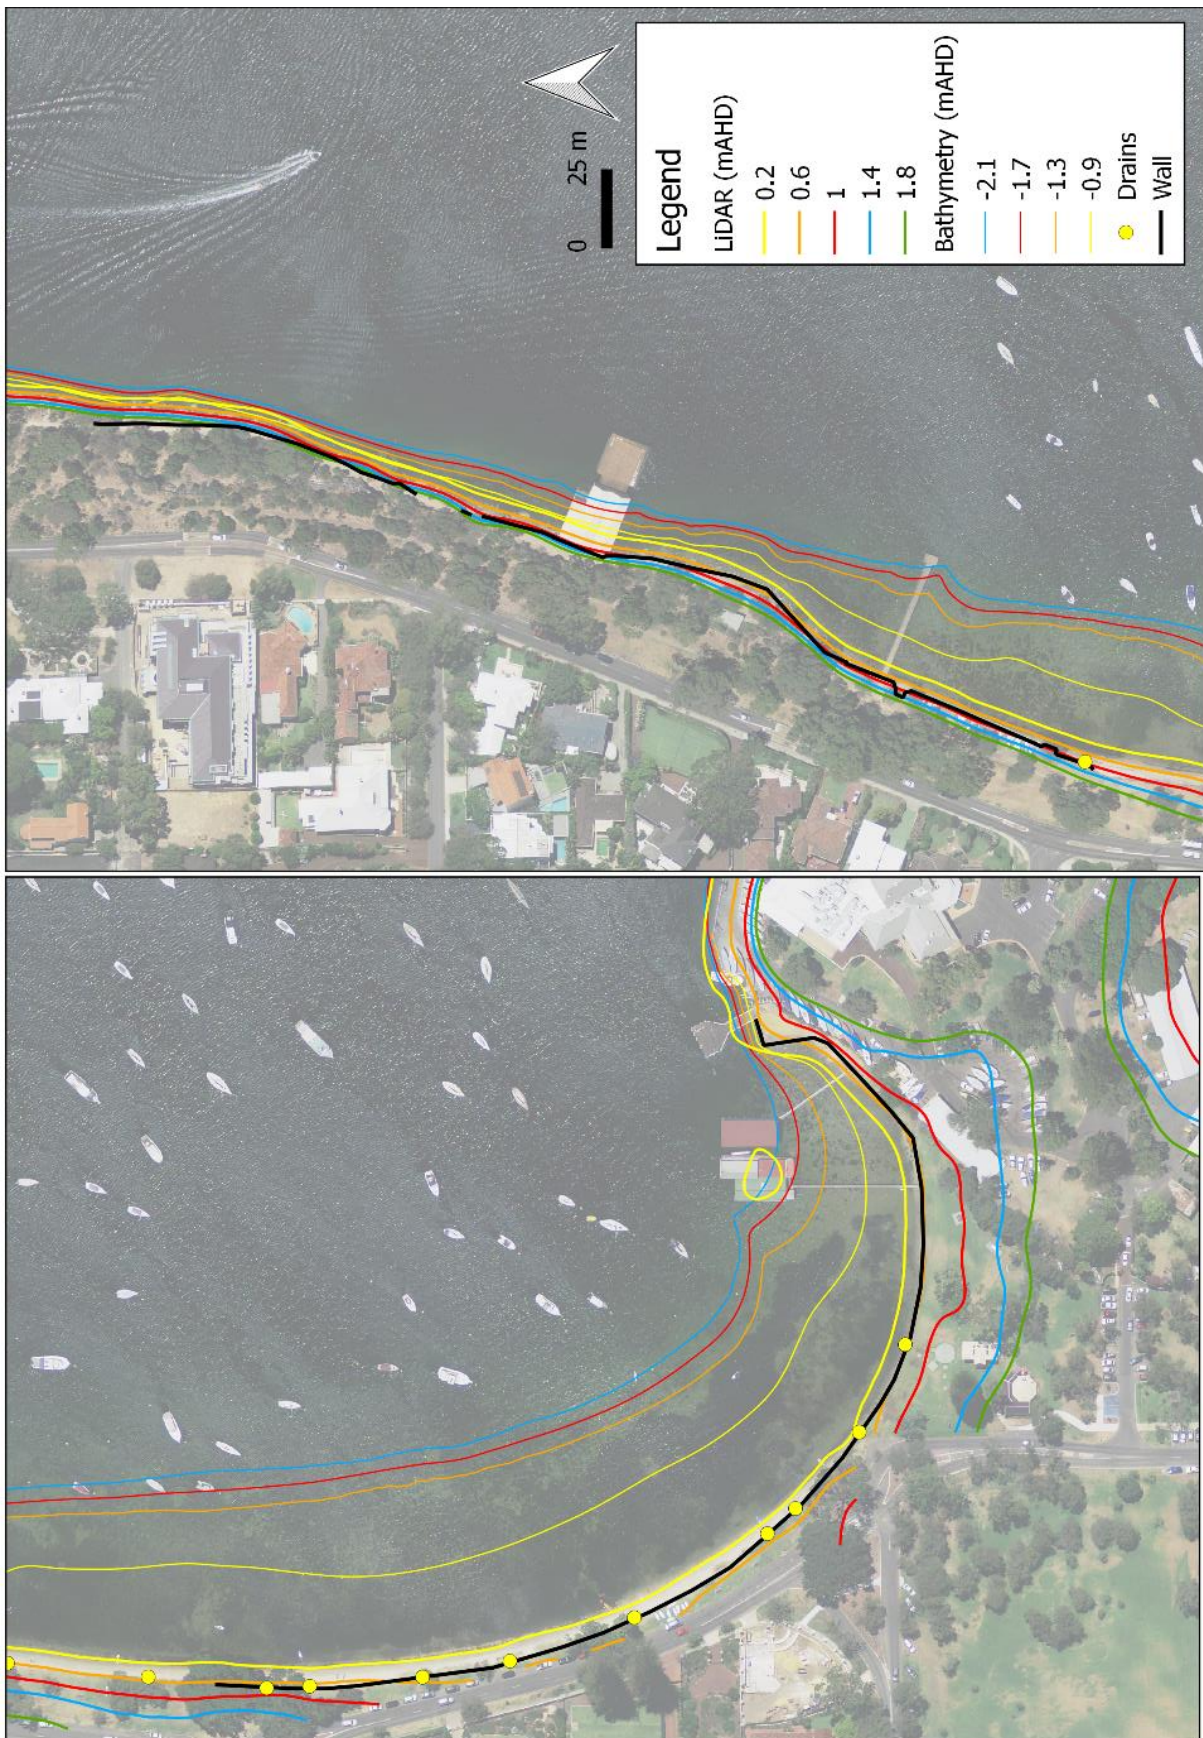
Figure 9-17: Topography and Bathymetry focusing on SRPep01 and SRPep02 in SoPG

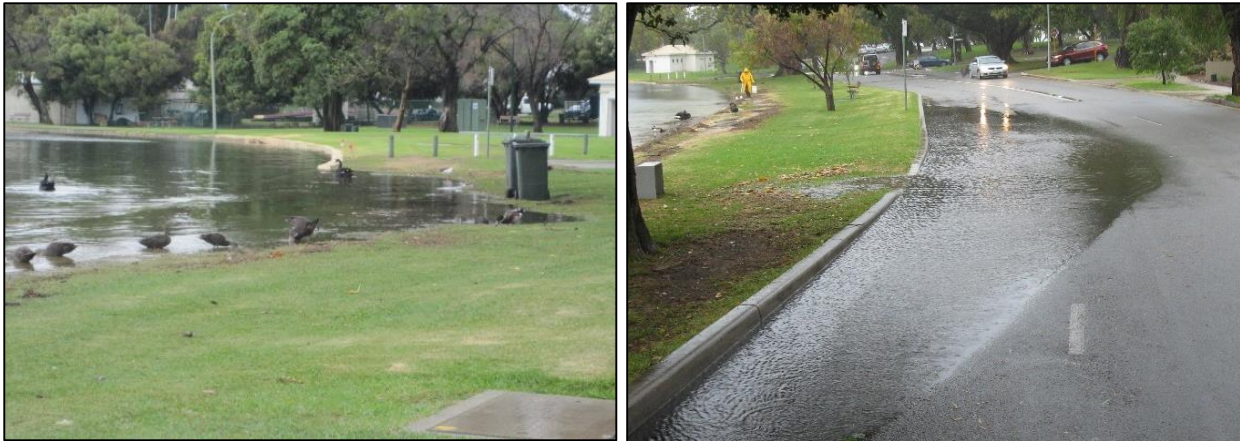
Figure 9-18: Inundation and Surface Runoff Ponding during 20 May 2011 Storm (Source: SoPG)

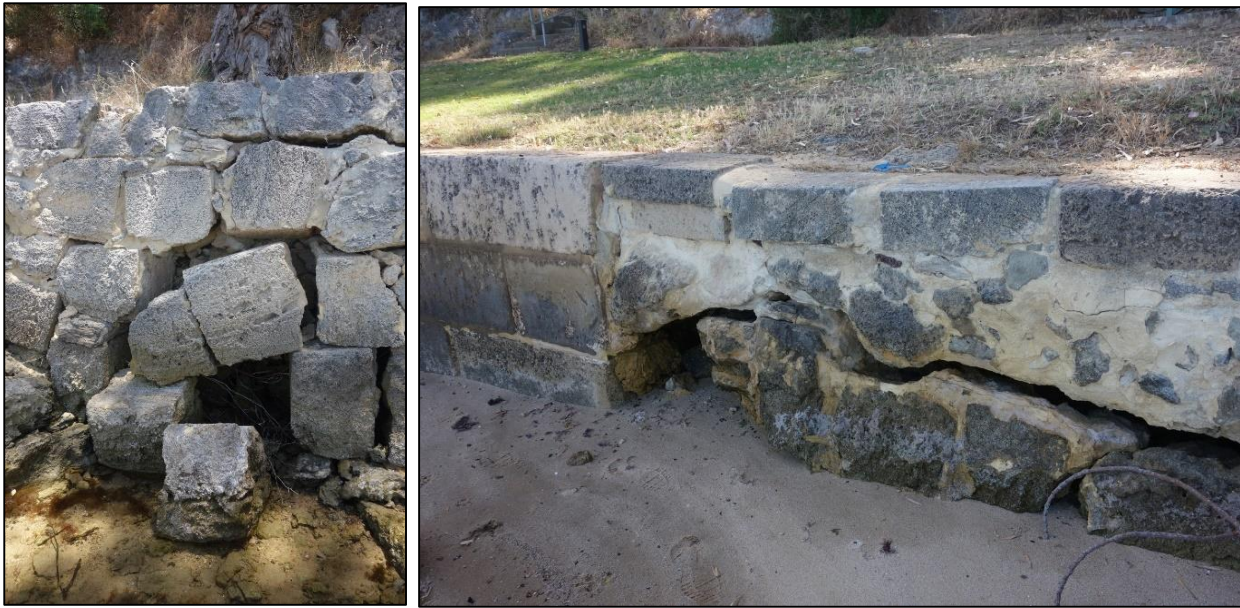
Figure 9-19: Some Examples of Walling in SRPep01 Requiring Maintenance (Jan. 2015)

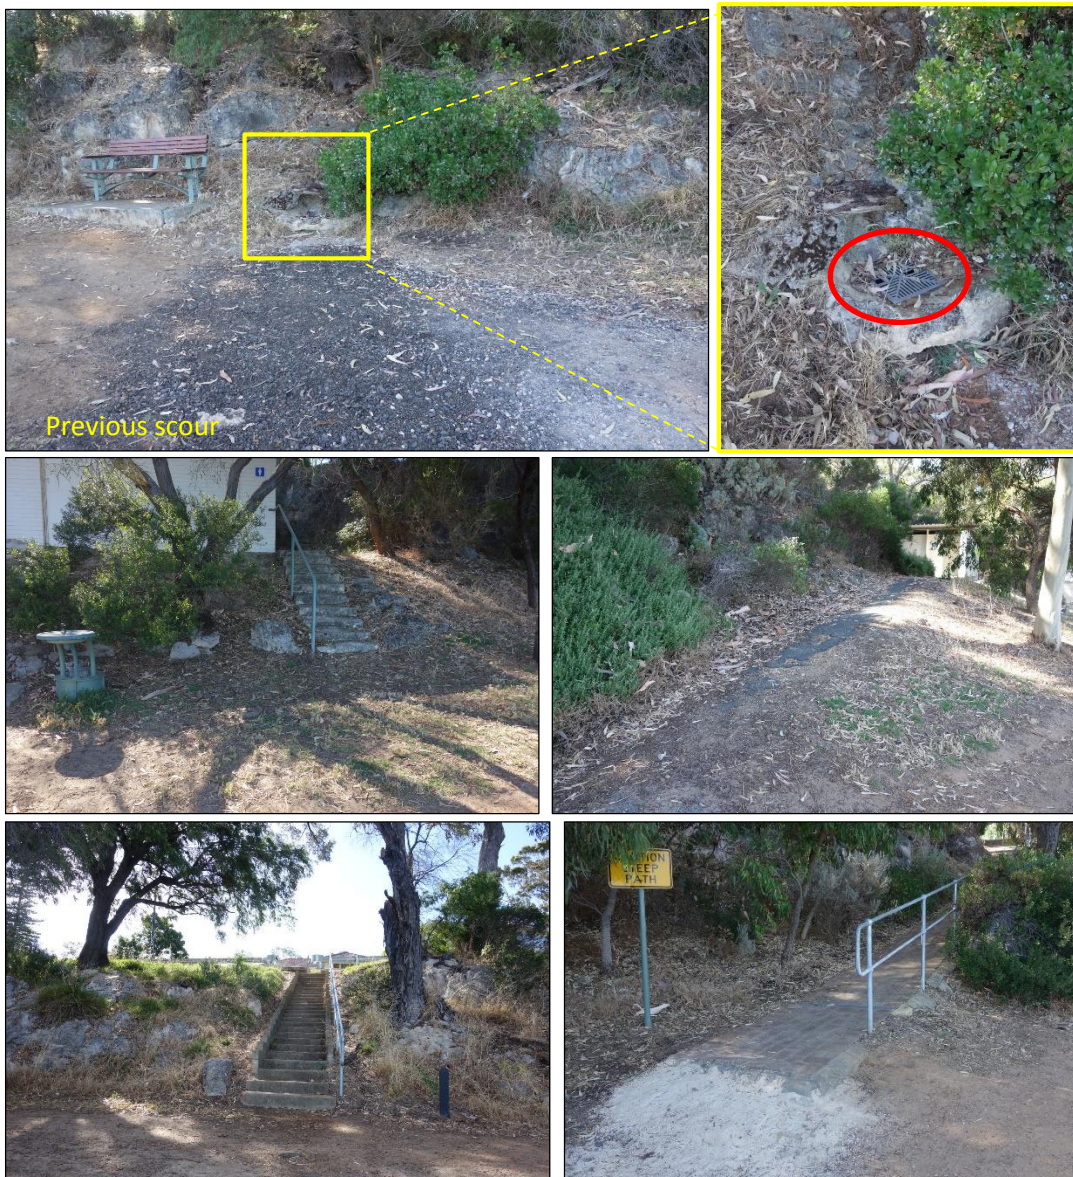
Figure 9-20: Examples of Unmanaged Surface Runoff in SRPep01 (Jan. 2015)

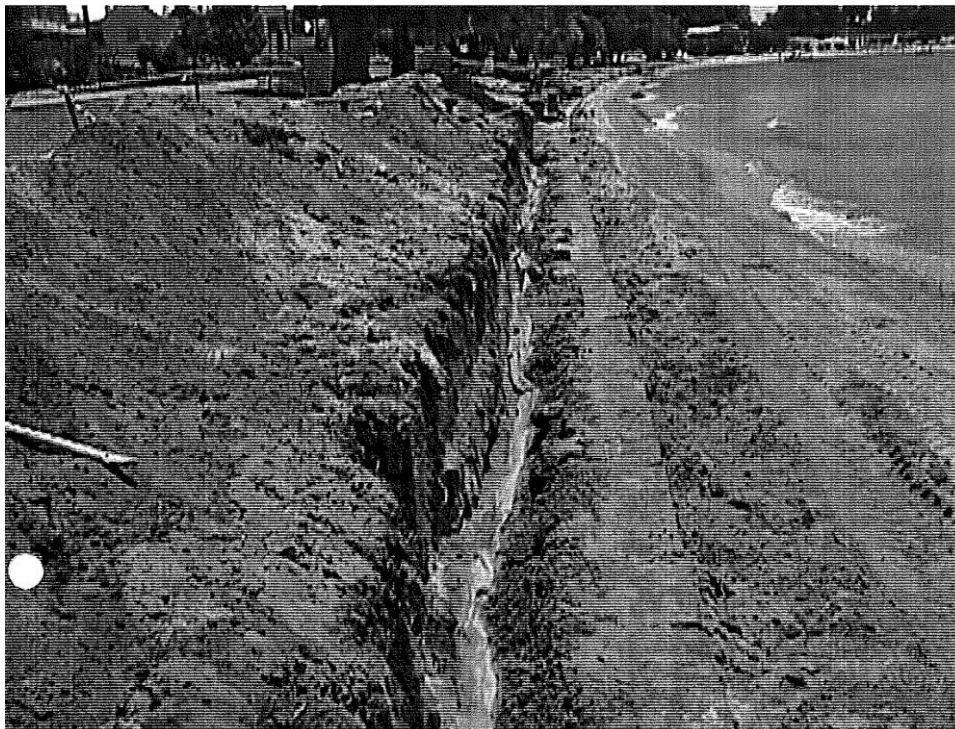
Figure 10-5: December 2001. Reconstruction of walled section between Mosmans and 185m walled section replaced in 2001 (SRT 2001)
