# LAKE CLAREMONT MANAGEMENT PLAN 2016 - 21

BIOPHYSICAL WETLAND VALUES - APPENDIX 1

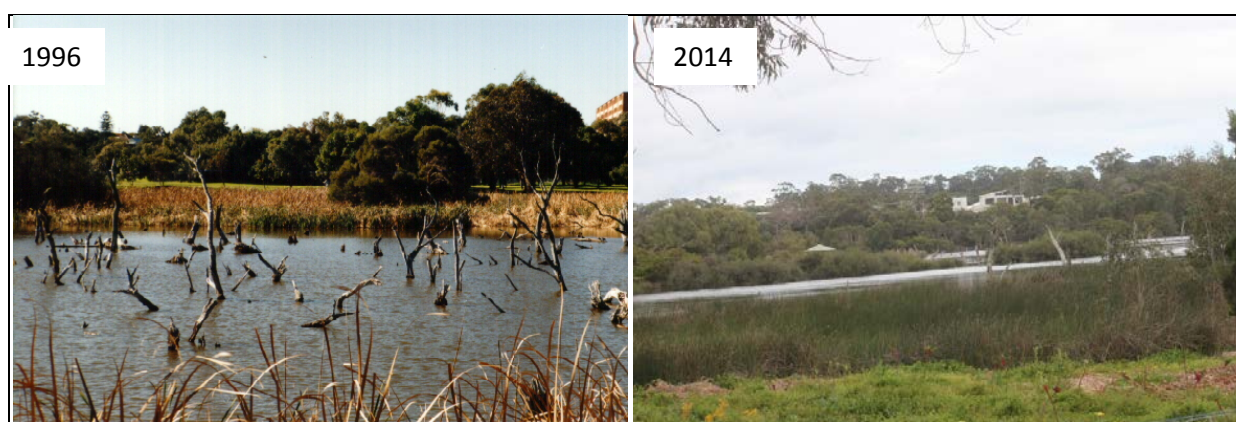
**Figure 4:** Removal of *Typha orientalis* at Lake Claremont

Lake Claremont includes a range of aquatic and emergent vegetation. Removal of large areas of *Typha orientalis* (Bulrush) from within the lakebed has occurred and replaced with a range of native sedges and rushes including *Bolboschoenus caldwellii*, *Ficinia nodosa* and *Schoenoplectus validus* (Figure 4). Benefits of the *Typha* removal include a reduced fire risk during summer months along with a greater diversity of water flora species. The replacement vegetation provides habitat and refuge for nesting aquatic bird species (Figure 5). Species that tolerate wet but not permanently inundated conditions occur around the edge of the water body, and include *Melaleuca raphiophylla* (Swamp Paperbark) and *Eucalyptus rudis* (Flooded Gum). The tree stumps present in the lake are the remains of Swamp Paperbarks killed by permanent inundation when water levels rose and the lake became a permanent water body in the first part of last century. While these stumps are breaking down naturally, they currently provide safe roosting locations for the birdlife of the lake.

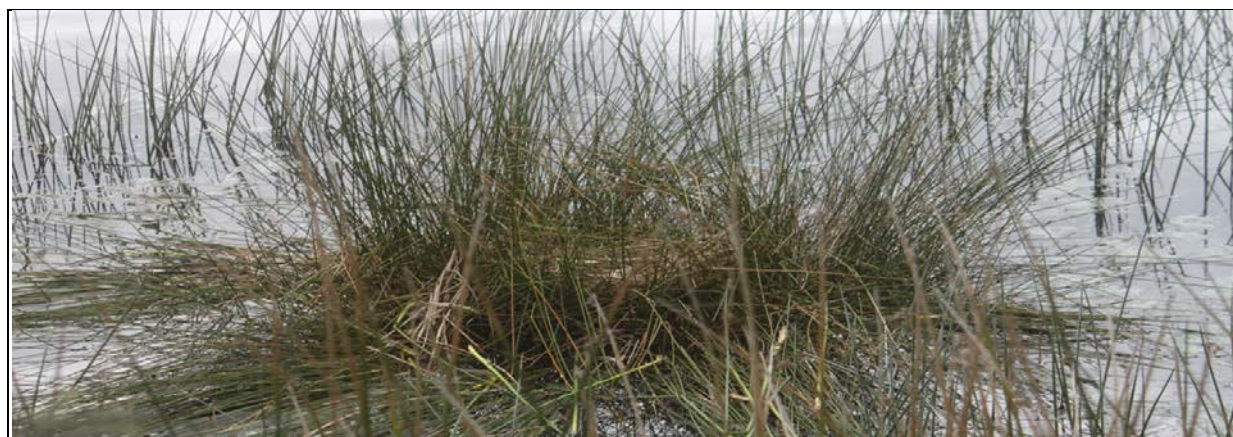
**Figure 5:** Aquatic vegetation used in nesting material

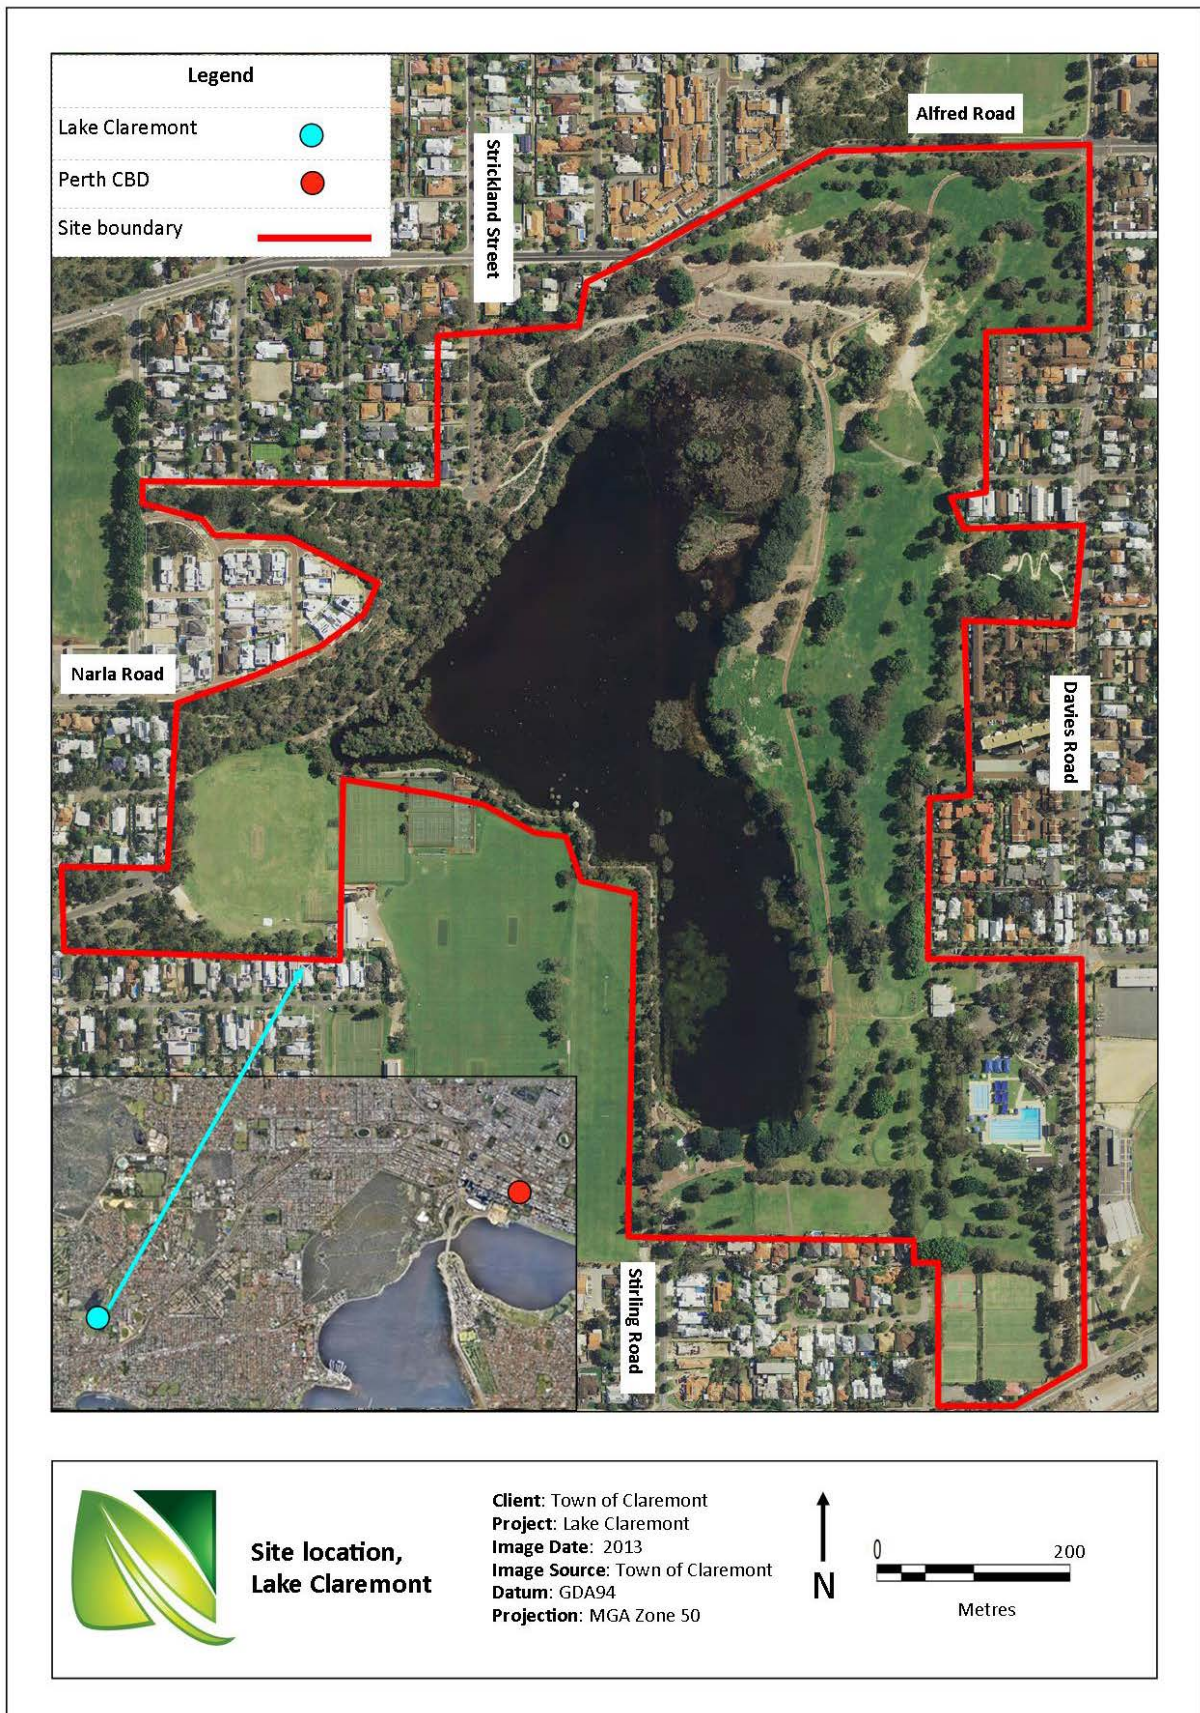
**Figure 1:** Site location, Lake Claremont

Lake Claremont is approximately 10 km southwest of the Perth Central Business District. The Lake Claremont site (Figure 1), including Cresswell Oval and Mackenzie Bushland, are defined by Alfred Road to the north, Davies Road to the east, private property and Shenton Road to the south and Strickland Street, Lakeway Estate and Narla Road to the west.
