Freshwater Bay Sand Management Plan

Prepared for Town of Claremont

Seashore Engineering

Document SE109.01

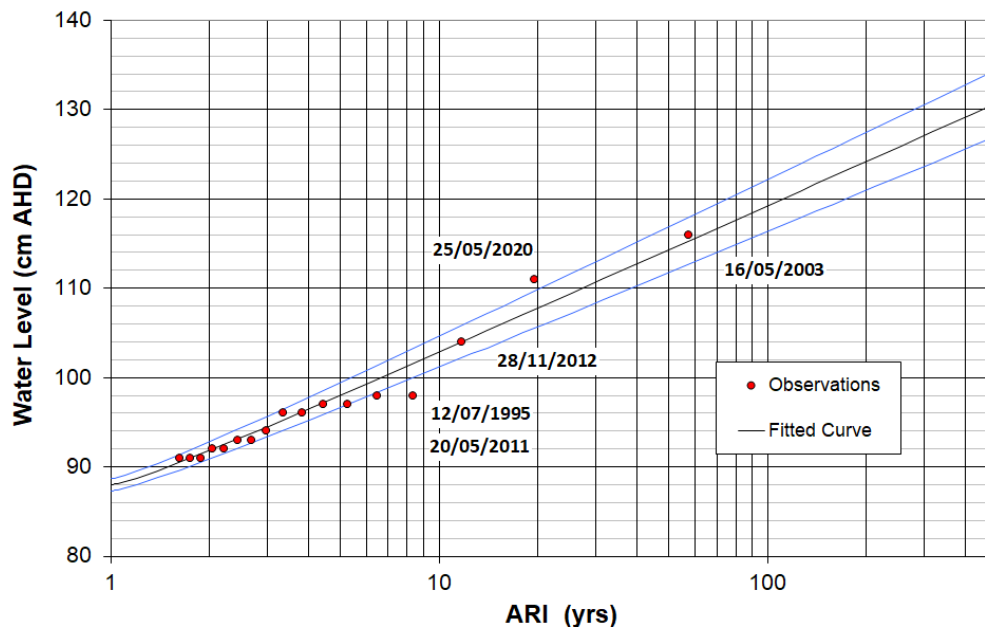
Figure 5: Barrack Street (Perth) Extreme Water Levels

The tide gauge record from Barrack Street indicates a distinct seasonal pattern, with high water levels mainly occurring during May to July, when tides, storm surges and seasonal mean sea level can be simultaneously high (Eliot 2012). Annual maxima are consequently always above highest astronomic tide (0.44m AHD), with a relatively 'flat' extreme distribution, as there is only ~0.3m between the 1-year average recurrence interval (ARI) level of 0.88m AHD and the 100-yr ARI level of 1.19m AHD.

A preliminary assessment of inundation hazard to Claremont foreshore has been undertaken through comparison of the water level record from Barrack Street (Perth) tide gauge with foreshore levels derived from LIDAR survey. It is recognised that water levels vary slightly between Claremont and Perth, and that inundation hazard is also influenced by the coincident wave conditions.

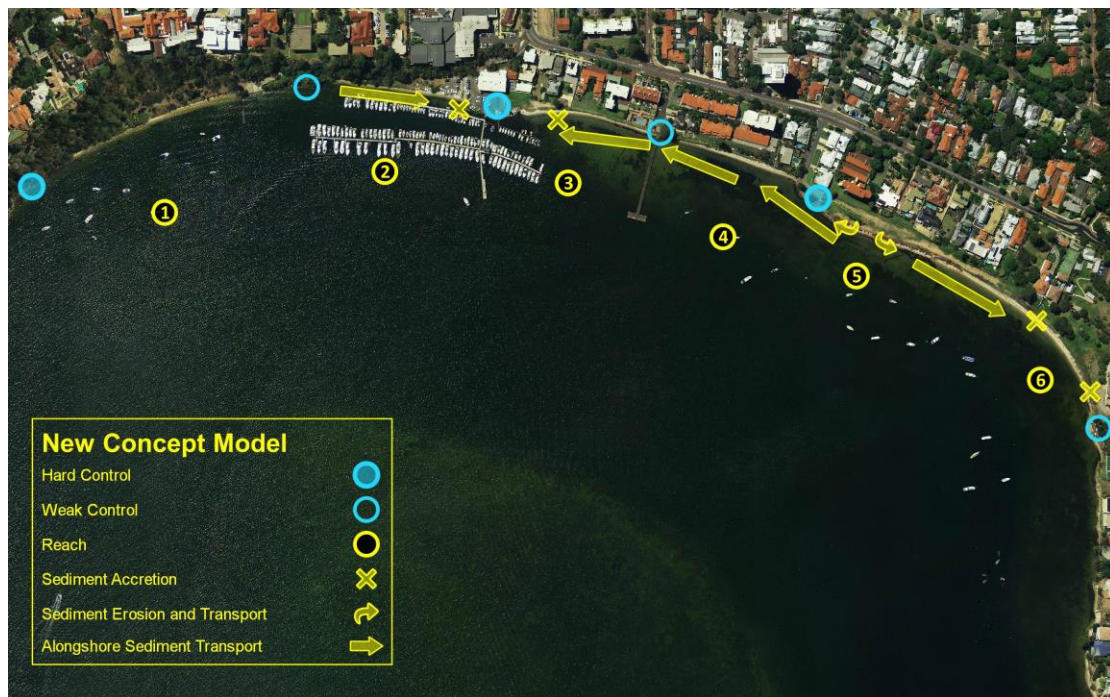
Figure 11: Conceptual Model of Claremont Foreshore Dynamics

A model of foreshore dynamics has consequently been developed (Figure 11), based on information summarised in Appendix A. Claremont Yacht Club, through its armoured hardstand and shelter from mooring pens, divides the foreshore and provides a focal point for deposition. Transfer from west of Christchurch Rowing Shed towards CYC has not been consistent historically, with the Christchurch boat ramp providing a partial (above mean tide) barrier to alongshore sediment transport between 2004 and 2018.

- When more broadly spaced, the capacity for a length of riparian vegetation to create a point of alongshore control should be recognised. The key implication is increased capacity for erosion on the downdrift side (Figure 11).

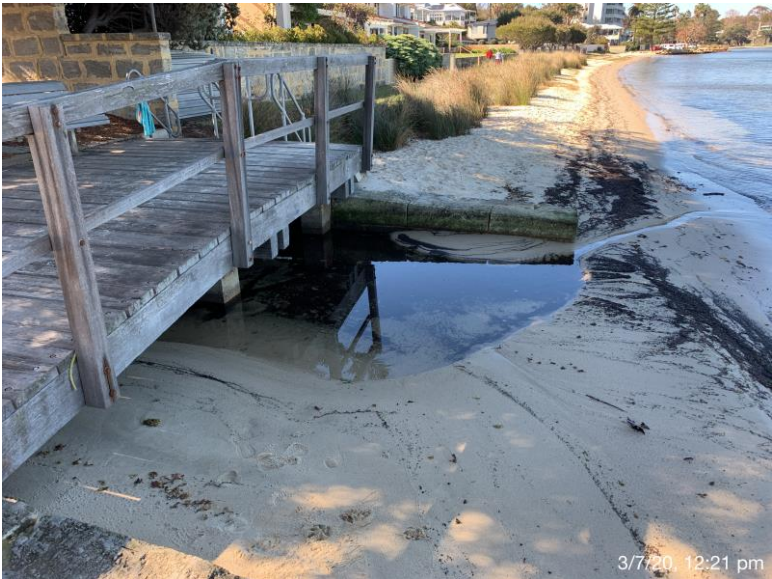
Figure 13: Stormwater Outlet

The large stormwater drain outlet adjacent to Claremont Jetty (Figure 13) provides a point of local scour and deposition due to variable stormwater flows. The cyclic pattern of scour and then infill, drawing from its surrounds, provides a local point of foreshore erosion pressure. Sediment in the vicinity of the drain may be mildly polluted from road runoff and therefore should not be used as a sand resource.

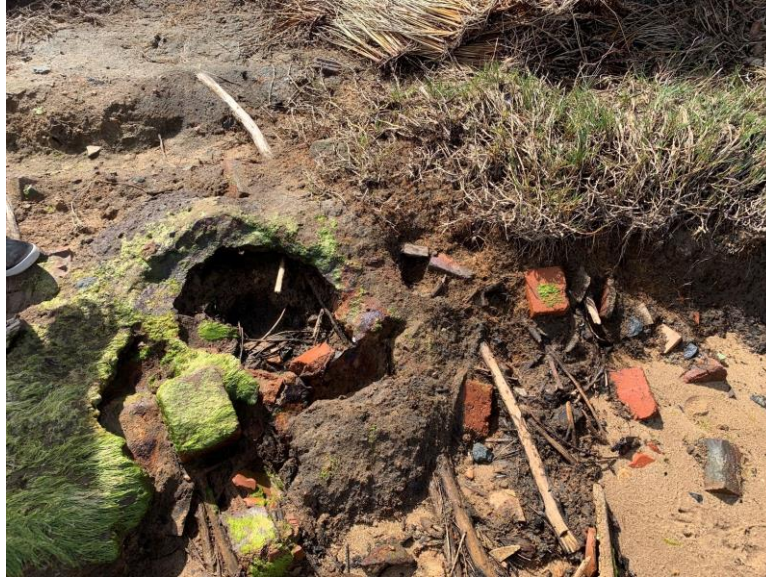
Figure 14: Rubble, debris and undercut sedge adjacent to Chester Rd revetment

The foreshore area including Chester Road carpark was reclaimed, using fill of mixed quality, apparently including rubble and debris. Foreshore erosion, including retreat after Chester Road revetment was shortened, has exposed the rubble including rusting metal (Figure 14). The extent and volume of rubble and debris located along the foreshore is unknown.

Existing knowledge of the rubble east of Chester Rd revetment suggests that it is mainly inert material and therefore it creates no adverse issues when buried. However, it is acknowledged that a series of partial removals as different areas become exposed is likely to provide ongoing poor amenity. Consequently, it is necessary to evaluate the total distribution of rubble and develop an achievable strategy for rubble management. An investigation combining ground penetrating radar with vacuum excavation (cost estimate \$5,000) is recommended as a first step, with subsequent options assessment by a geotechnical professional.

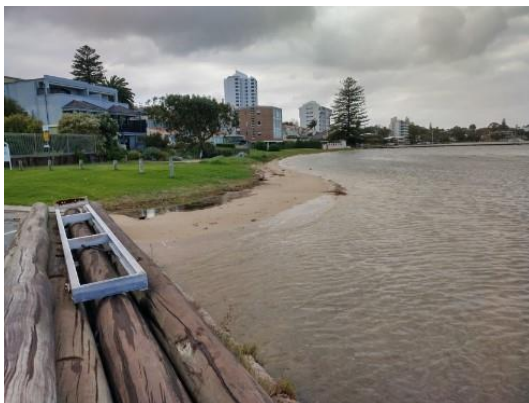
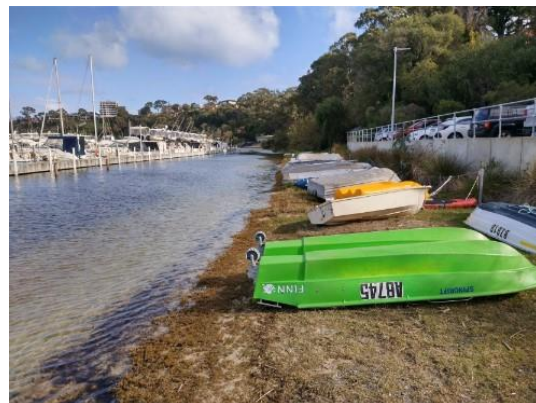
Figure 17: Existing Points of Deposition

- Ongoing accumulation of approximately 50 m³/yr east of Claremont Yacht Club (Figure 17a) may be considered a sustainable source for the next 10 years. This was previously used as a resource by the Swan River Trust, who (anecdotally) undertook local backpassing. Over longer time frames, this rate of deposition will slow as the foreshore continues to erode and due to effects of sea level rise, effectively ceasing by 2070.

- Existing deposition to the east of Claremont Yacht Club has been estimated at up to 650m³. This is a non-sustainable sand resource.
- Deposition west of CYC hardstand has been occurring at roughly 20-30m³ over the last 65 years (~1600m³). Land created by this deposition provides a narrow and low-lying foreshore buffer in front of the Claremont Yacht Club carpark extension, built in 2015. Capacity to extract sediment from this area is limited by its existing role as a buffer and dinghy storage area, with approximately 100m³ considered presently available (Figure 17b). Extraction of the low and shallow volumes of deposited material would best be undertaken using beach scraping, with at least 5 years before further extraction.

(a) Deposition Lobe east of Claremont Yacht Club (b) Deposition area west of Claremont Yacht Club

- Identification of approximate sand volumes available adjacent to CYC on the beach. This requires that the beach is not 'concave' (steep adjacent to vegetation), with a clear beach ridge and no scarping (see Figure 17a for an example). An estimate of available volume shall be based upon 0.1m times the width and length of the beach. It is anticipated that sand harvesting from this beach can be achieved every 1-2 years.

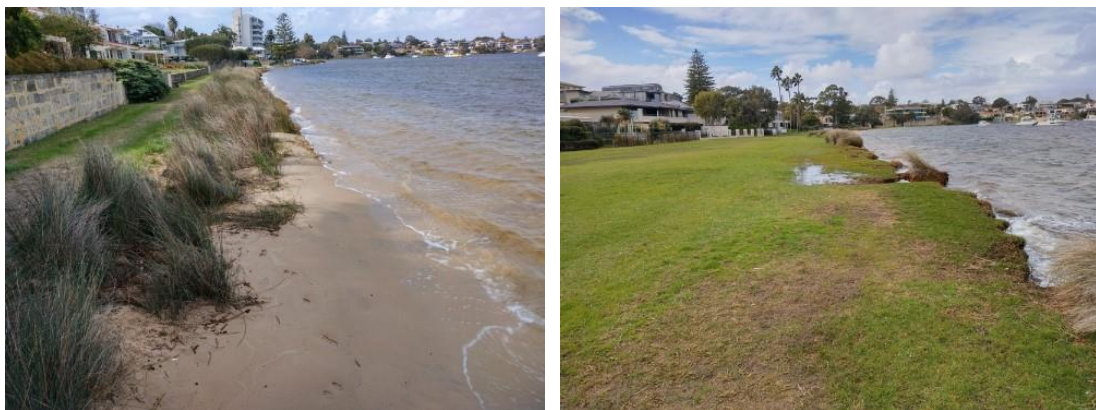
Previous planting of riparian vegetation has focused on use of *juncus kraussi*, which preferentially occupies the upper intertidal zone (0.3 – 0.7 m AHD). For the prevailing structure along Claremont foreshore, there is a narrow niche which can be occupied, generally resulting in a narrow fringe of riparian vegetation (Figure 19). This fringe can be fragile, subject to undercutting during storm events, or it may actively trap sediment, helping to build a foreshore berm.

(a) *Juncus kraussi* fringe in moderate health

(b) Remnant *juncus kraussi* fringe

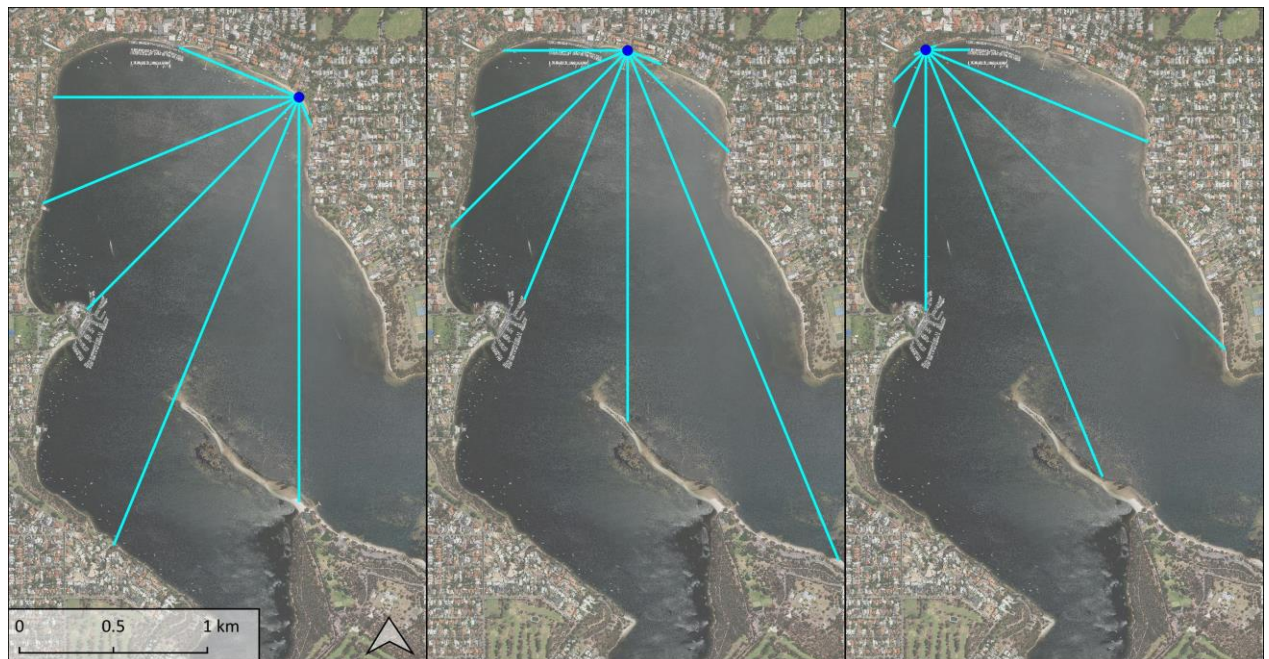
Figure 22: Freshwater Bay Indicative Wind Fetches

- Melville Water wind record, from the Bureau of Meteorology weather station AWS9091, is available from 1999-2020. The wind record indicates the capacity for wave generation across the surface of Freshwater Bay, although this is modulated by the effective fetch (Figure 22), increasing waves generated by southeast winds on the west side of the bay and increasing waves generated by southwest winds on the east side of the bay.

The effect of seasonal changes to wind direction is modified by the sheltering provided by land and the relative capacity for wave generation across Freshwater Bay (Figure 22). Consequently, only winds from the southerly half of the compass have been considered when looking at year to year variability.

Available fetches (Figure 22) have been combined with the wind distribution (Figure 29) using a vector sum of $\sum_{\theta=0}^{360} F_{\theta} f_{\theta}$ where F_{θ} and f_{θ} are fetch length and wind occurrence corresponding to direction θ . For a fetch-restricted shore, monthly vector sums (Figure 32) indicate wave climate variation over the year, with deviation from the mean direction suggesting a tendency for alongshore transport. Note that wind directions do not directly

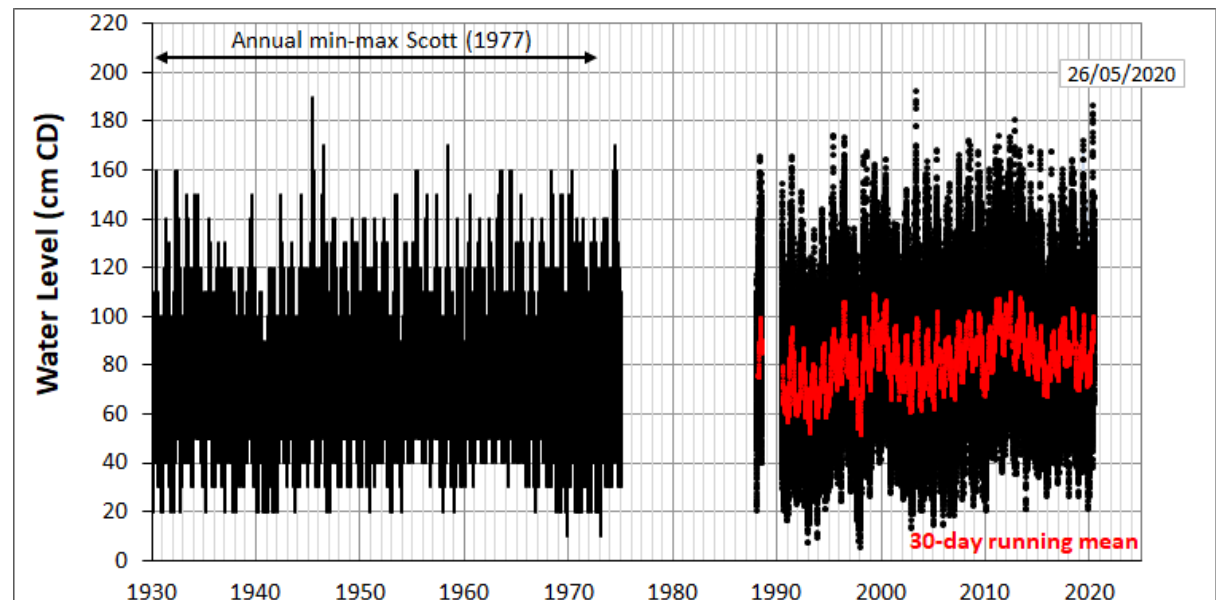
Figure 23: Barrack St Tide Gauge Entire Historic Water Level Record

Long-term water level measurements from Barrack Street (Perth) tide gauge (Figure 23) show historic annual maximum-minimum water levels digitised from tide traces (1930-1977), and hourly digital observations (1988-2020) from the Department of Transport tide gauge. The record reflects:

- Microtidal conditions, which are mainly diurnal, with one high tide per day.
- An overall rise, which corresponds well to the 20th Century trend observed at Fremantle ($\sim 1.7\text{mm/yr}$), which reasonably matches estimates of global mean sea level rise (Douglas 2001).
- Inter-annual mean sea level variability, which is strongly linked to global-scale climate fluctuations, which contributed to a rapid rise from 1990 to 2011 (White *et al.* 2014).
- Seasonal and episodic variability, with high water levels mainly occurring in May to July. The highest water levels are all associated with extreme storm surges, although storm type and surge processes may vary through the year (Eliot 2012, Pattiaratchi & Wijeratne 2014).

Notably, since 2000, 7 of the 10 highest recorded water level events have been observed, indicating increased recent stress. It is notable that this period is a result of several different phenomena, including a period of sustained high mean sea level in 2011-2013.

Chart Datum (CD) is approximately 0.76m below Australian Height Datum (AHD), which roughly corresponds to mean sea level.

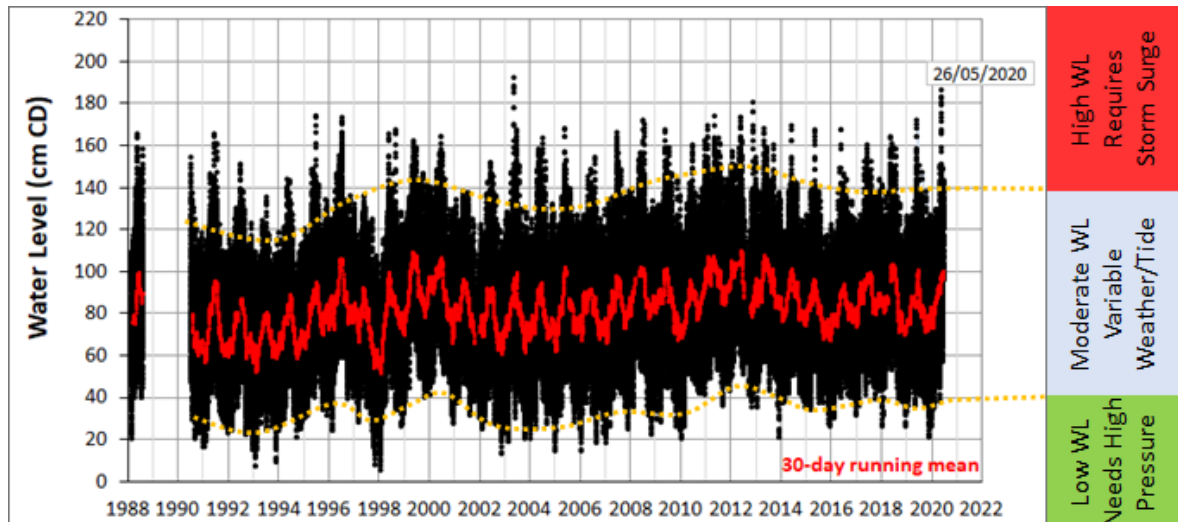
Figure 24: Barrack St Tide Gauge Modern Water Level Record

The modern water level record from 1988-2020 (Figure 24) more clearly illustrates the ‘spiky’ nature of high water level events, with most water levels above 1.4mCD (0.84mAHD) lasting for <12 hours. Below this approximate threshold, there is a significant increase in water level occurrence, as levels can be reached by a combination of high tide with small surge, or high surge with moderate tide.

Chart Datum (CD) is approximately 0.76m below Australian Height Datum (AHD), which roughly corresponds to mean sea level.

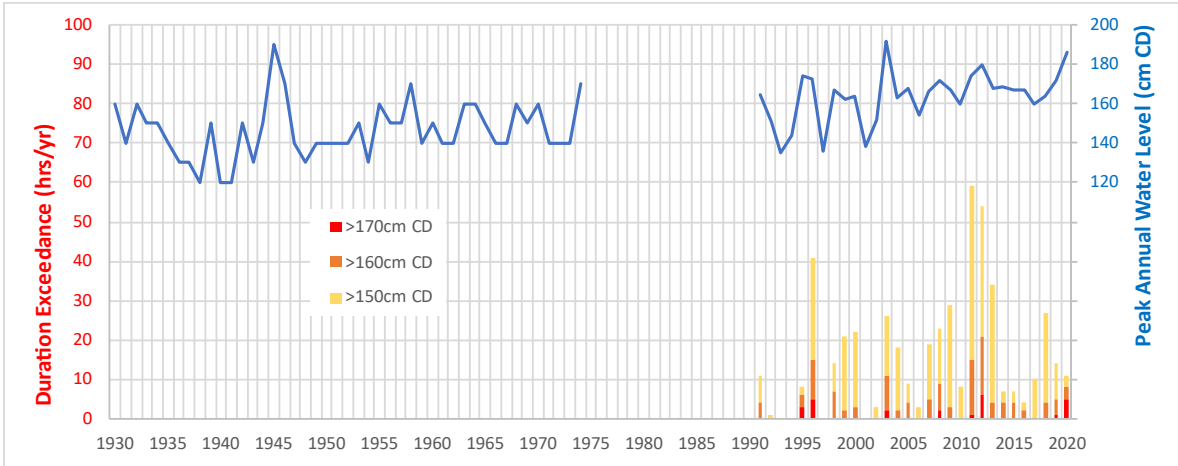
Figure 26: Barrack Street Annual Exceedance Rates and Maxima

The significance of different processes contributing to high water level events for foreshore management is illustrated by time series of annual threshold exceedance rates and annual maxima (Figure 26). As inundation of the Freshwater Bay foreshore commences at approximately 1.55mCD (0.79mAHD), a relative indication of foreshore stress is suggested by exceedance around this threshold. Exceedance varies substantially from year to year, corresponding poorly to annual maxima. It is noted that the period of greatest exceedance was 2011-2013, which corresponded to high mean sea level conditions during the ‘marine heatwave’ caused by a severe La Niña climate phase (Bureau of Meteorology 2012).

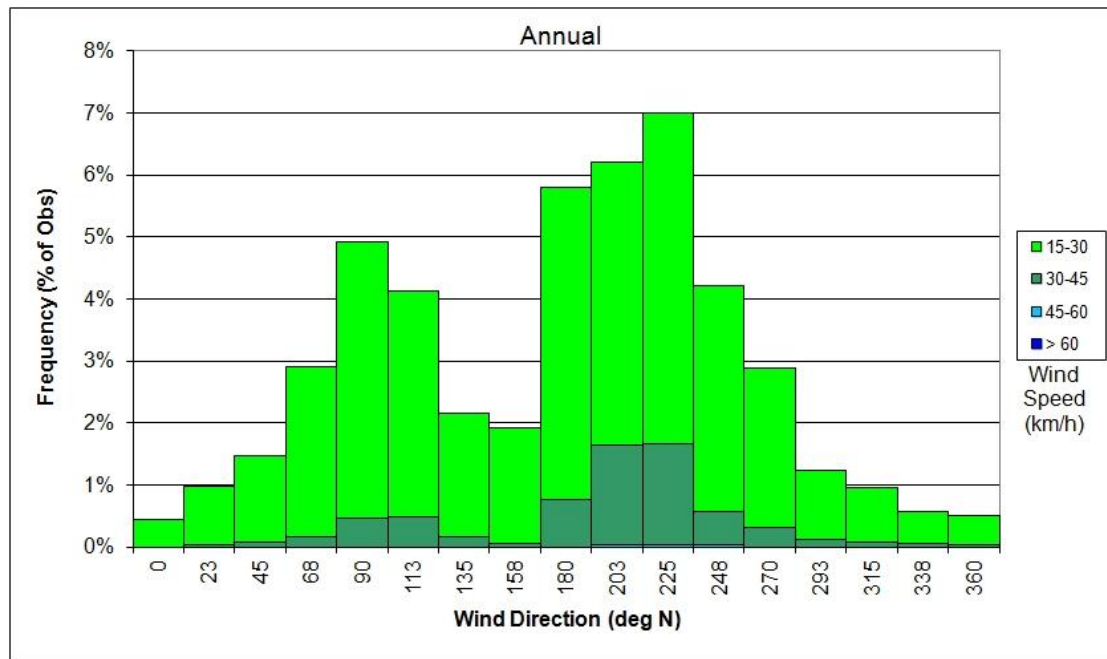
Figure 27: Annual Average Wind Speed and Direction Distribution

The overall wind record suggests a generally bimodal pattern of easterly and south-southwest winds (Figure 27), which is characteristic of the land-seabreeze cycle prevailing for much of the year in Perth.

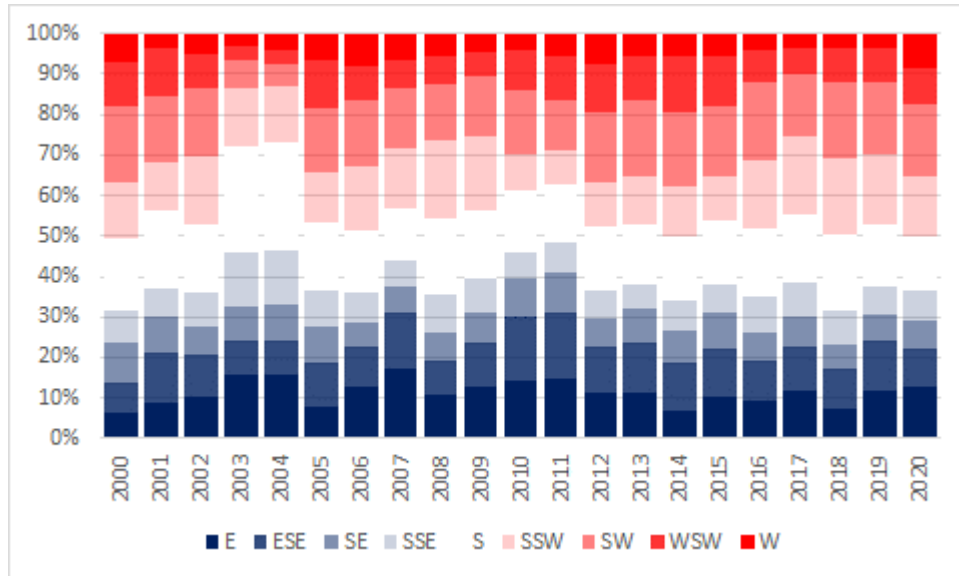
Figure 30: Interannual Variability of Summer Onshore Wind Distribution

The directional distribution of summer winds, presented as a percentage of winds from east through west, from September to March (Figure 30) shows inter-annual variability. Occurrence of westerlies displays cyclic tendency, but easterlies are more variable on a year-to-year basis. Note that behaviour in 2003-2004 is possibly a local instrument issue.

- Slightly increased incidence of westerly winds during recent years (Figure 30 and Figure 31).
- Removal of the concrete ramp may have removed a partial foreshore control, allowing greater movement of the beach (west of the Boat Shed) towards the east.
- If the beach was rebuilt 'further out' than its original position, then it is expected that the extra material will be dispersed in both directions.
- Layout of the gabions does not parallel the foreshore, with a 'point' near the eastern end of the walling, which is subject to more frequent exposure to wave action.
- Gabion walls cause greater wave reflection than a sandy foreshore, which will result in local flattening of the beach profile when the gabions are reached by waves under high water level events. This potentially causes local lowering of the beach.
- The toe mattresses have been placed with limited embedment.

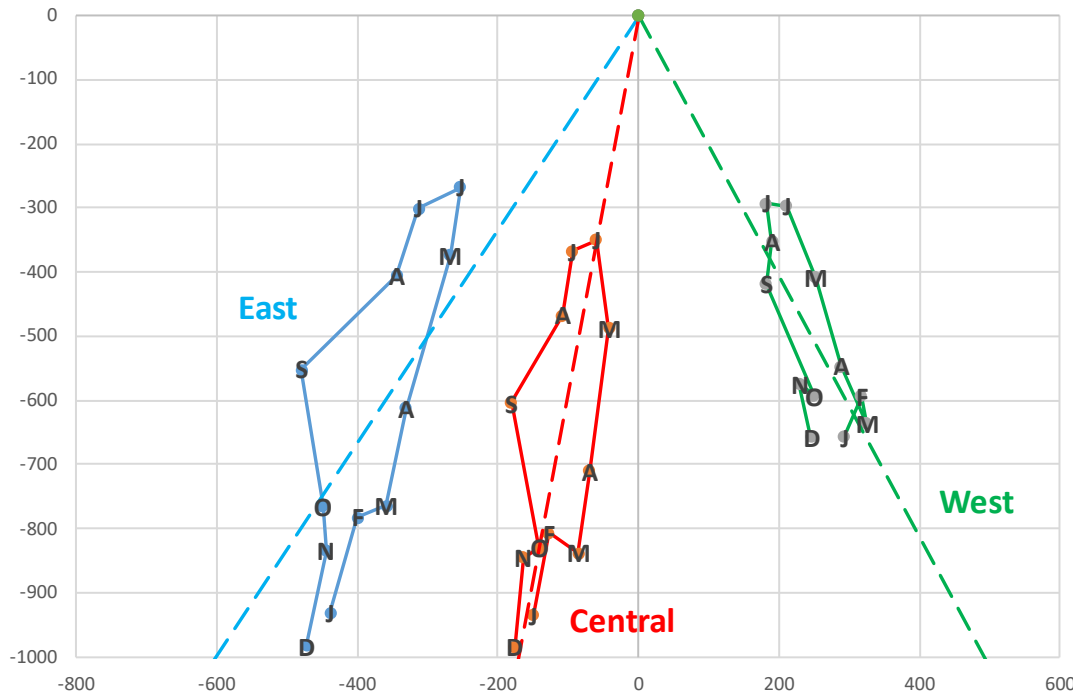
Figure 32: Seasonal Variation of Wind-Fetch Alignments

correspond to wave directions, particularly due to the process of refraction as the waves approach the shore, which is modulated by water level.

Monthly vector sums developed for three points along northern Freshwater Bay suggest different annual sequences:

- Average wave conditions west of Claremont Yacht Club tend to be from the south-southeast, with winter conditions (April to August) tending to have a small increase in easterly component (i.e. beach sediments will generally move westward during winter and east during summer). This interacts with seasonal sea level variability, such that the foreshore beach near Christchurch Rowing Shed is likely to be narrow over winter.

- Average wave conditions for the central section of Claremont foreshore are approximately straight on to the shore, being slightly west of south. Fluctuations in direction occur during March to May, when westward transport is likely and July to September, when eastward transport is likely. This is out of phase with seasonal fluctuations in sea level and therefore foreshore behaviour may appear erratic.

- Average wave conditions east of Alex Prior Park tend to be from the south-southwest, with winter (May to September) tending to increase the westerly component. This is expected to cause a seasonal oscillation, in the opposite direction to the beach west of Claremont Yacht Club. Combined with seasonal sea level change, this is likely to cause large beach width variation between Alex Prior Park and Mrs Herbert's Park.

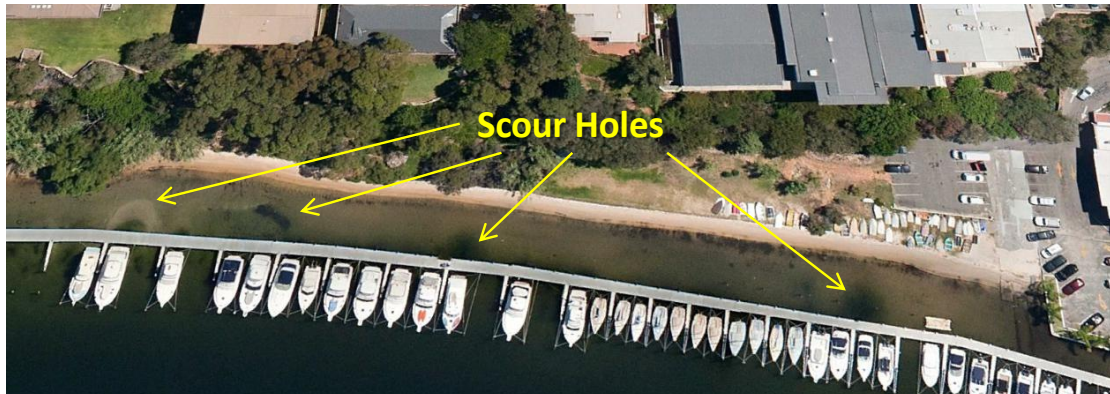
Figure 34: Scour holes caused by vessels in yacht club pens

Construction of yacht club facilities caused the expected division of the estuarine beach along northern Freshwater Bay. The hardstand provided a direct barrier to alongshore sediment transport and the pens provided an area of wave shelter, which has expanded with growth of the facilities. Sand trapping on the west side of the hardstand has occurred, however, it has developed slowly (10-15m over 65 years), with an almost straight beach structure. Sheltering from the yacht club pens determines that there is limited wave forcing on the beach, with scour holes caused by boat propellers able to persist for a long time (Figure 34).

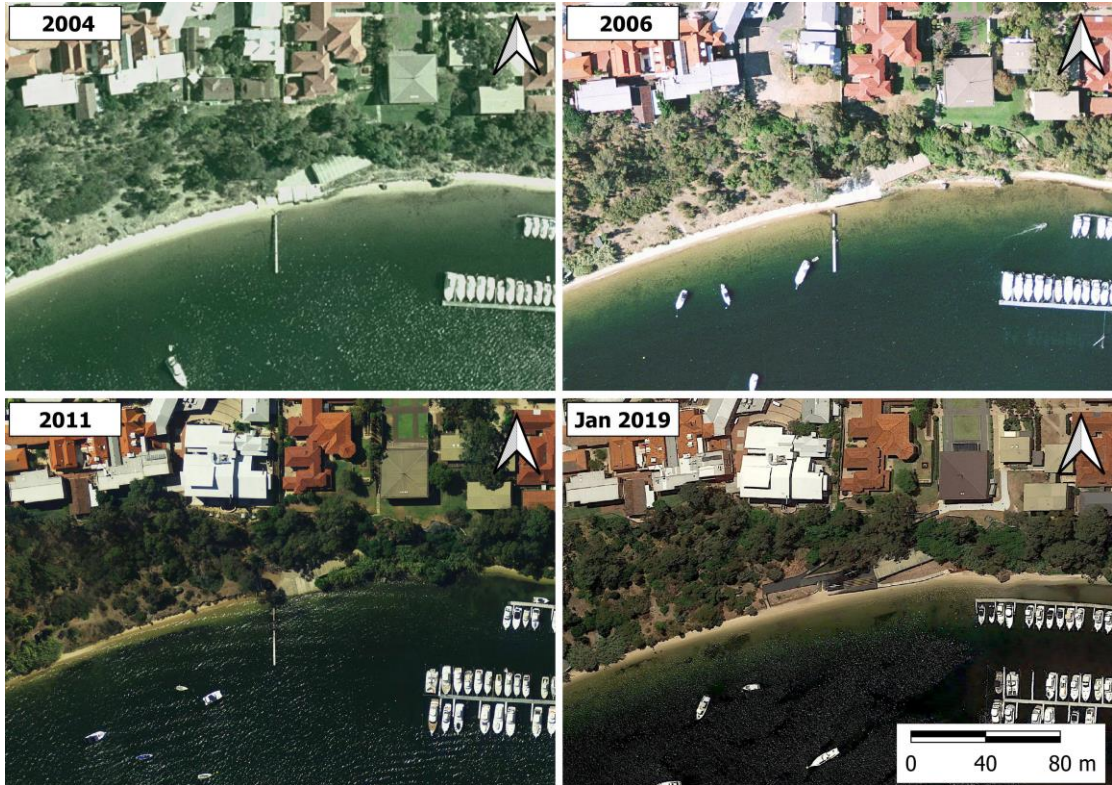
Figure 35: Changing shoreline connectivity near Christchurch Rowing Shed

West of Claremont Yacht Club, there have been three distinct phases of foreshore condition (Figure 35). Prior to 2003, the beach was continuous from Cliff Rd to CYC hardstand. From 2004, the beach became disconnected, with Christchurch Rowing Shed ramp and an outlying rock apparently providing partial foreshore control. This change followed from an extreme storm in May 2003, and a program to remove giant bamboo from the foreshore, however, neither has been established as contributing to the beach change.

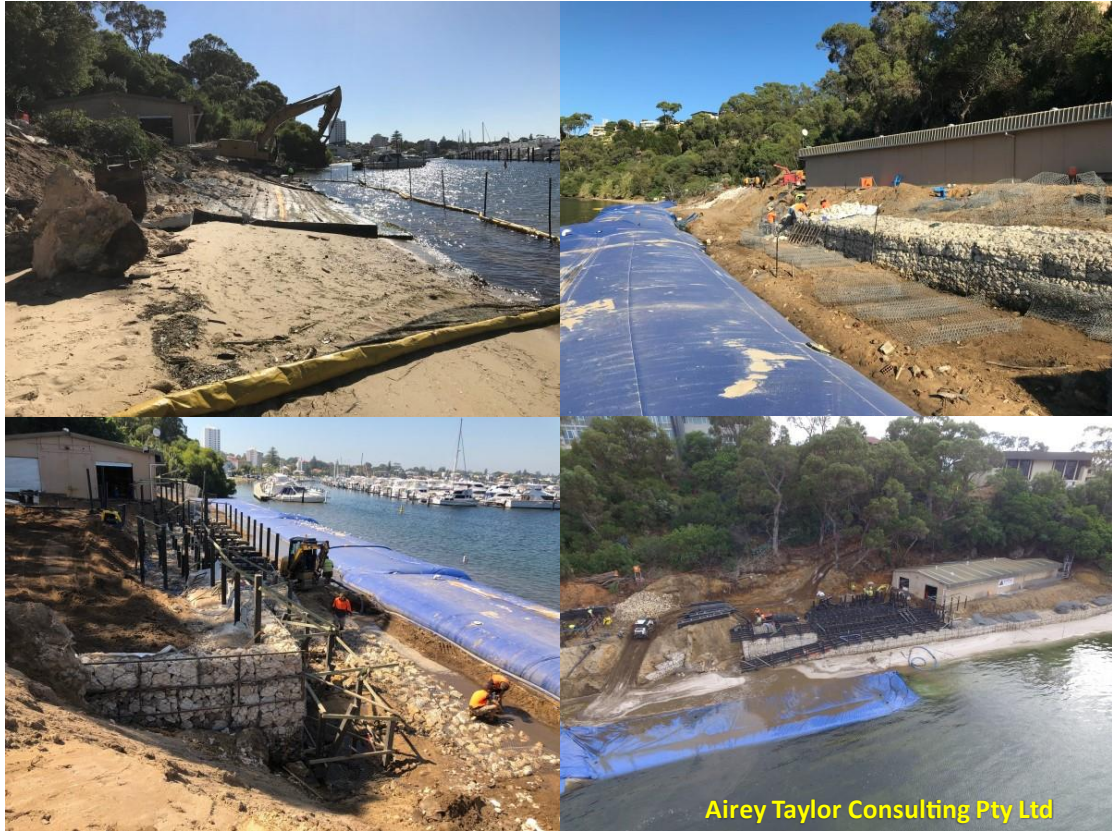
Figure 36: Reconstruction Works at Christchurch Rowing Shed

Redevelopment works at Christchurch Rowing Shed were undertaken in 2018 (Figure 36), including removal of the previous concrete ramp and construction of gabion walling, fronted by rock toe mattresses. After these works there has been increased foreshore continuity, potentially allowing increased sediment to move toward Claremont Yacht Club. Anecdotally, the beach in front of the Rowing Shed has lowered, occasionally exposing rock toe mattresses. These changes may reflect the following processes:

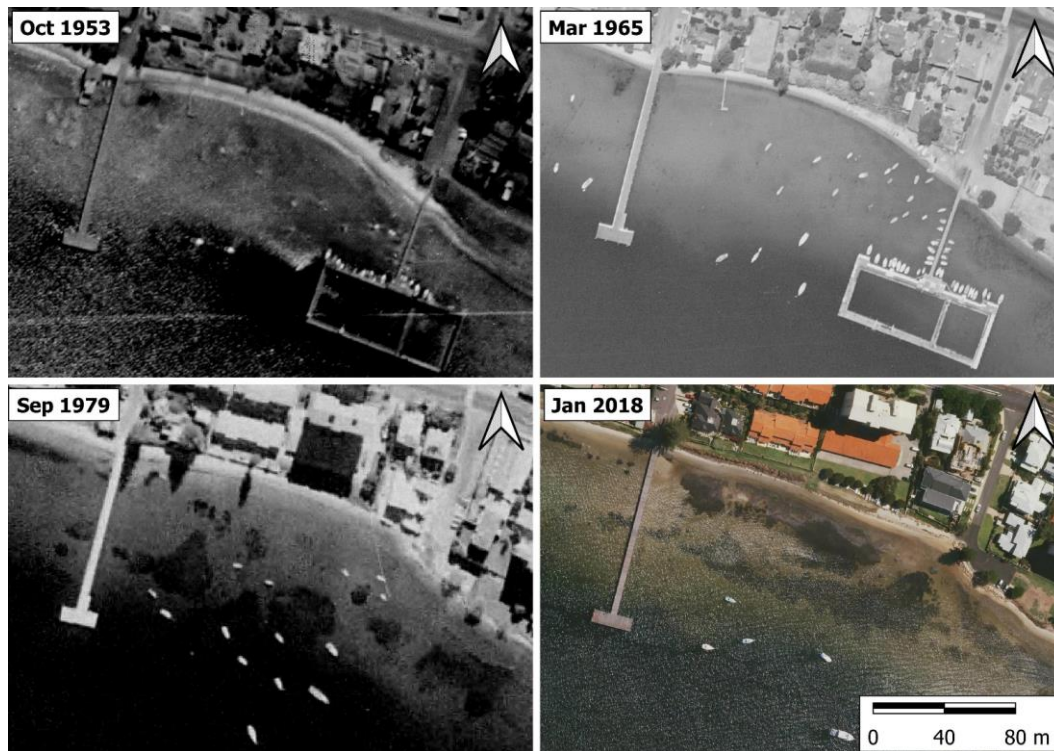
Figure 38: Claremont Jetty to Chester Road, historical change 1953 to 2018

The revetment was upgraded in late 2017 to increase hydraulic smoothness, including truncation of the eastern end and adding a more gradual tie-in to the east. There is a large water drain outlet located directly to the east of the Claremont Jetty abutment. During times of high rainfall, this drain mobilises sediments locally from the beach into a nearshore delta structure next to Claremont Jetty, which can be seen in the 1953, 1979 and 2018 photographs of Figure 38.

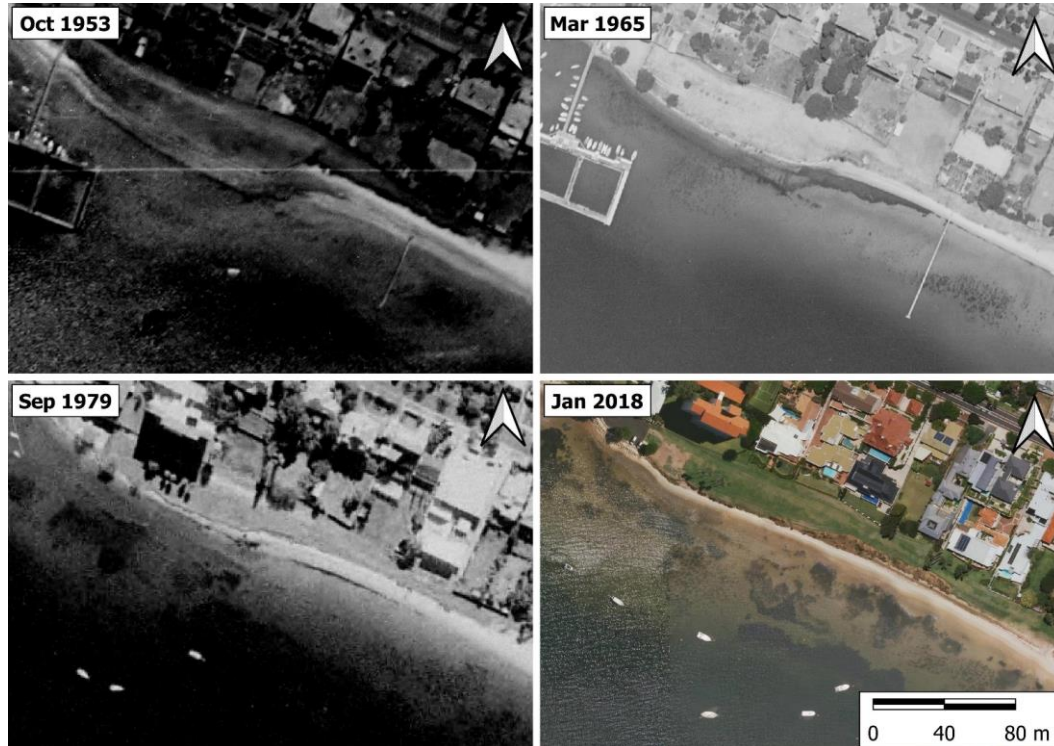
Figure 39: Retreat of historic reclamation area, east of Chester Road seawall

The shoreline protrusion inherited from historic reclamation east of Chester Road, has played a key role in the sediment dynamics along the wider Claremont foreshore since 1953. This reclaimed area has been progressively eroding (Figure 39), with this section of Freshwater Bay realigning to a straighter shoreline over time, as can be observed in the photographs of Figure 39. This has involved sediment redistribution both to the west and

east, contributing to ongoing accumulations evident at the CYC and eastern foreshore, respectively. It is recognised that the potential for sediment transport to the east was likely increased following removal of the Claremont Baths in 1971, which permitted more locally generated westerly wave energy to reach the shoreline.

The rate of shoreline realignment was relatively high in early imagery from 1953 to 1979 and has apparently declined as the shoreline has straightened with influence control being provided by the Chester Road revetment.

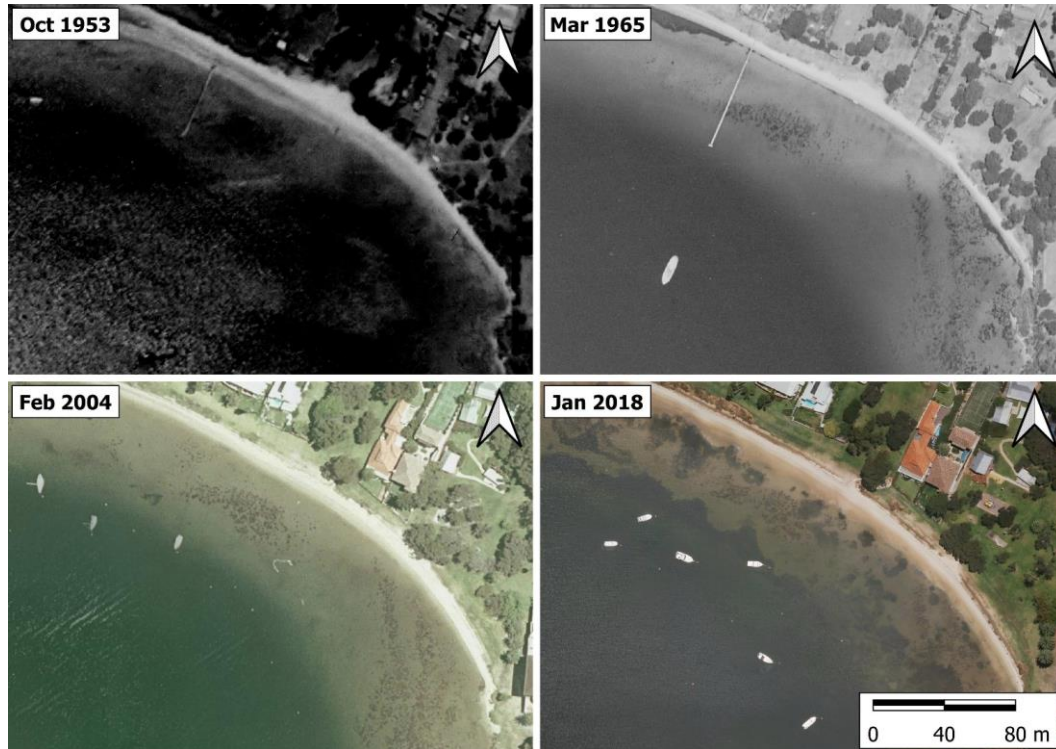
Figure 40: Eastern foreshore, historical change 1953 to 2018

This section of shoreline has been accreting since the 1950s. Further eastwards, the City of Nedlands extended Watkins Road and installed bioengineering foreshore treatment with a rock toe on the foreshore in 2015. This resulted in a hard-engineered control structure functioning at the eastern extent of Town of Claremont's beaches. The structure appears to be trapping sand and preventing it from travelling further south towards Point Resolution. Along the entirety, the eastern foreshore is accreting, with sediment supplied from the realignment of the large reclamation area east of Chester Road, refer Figure 40.

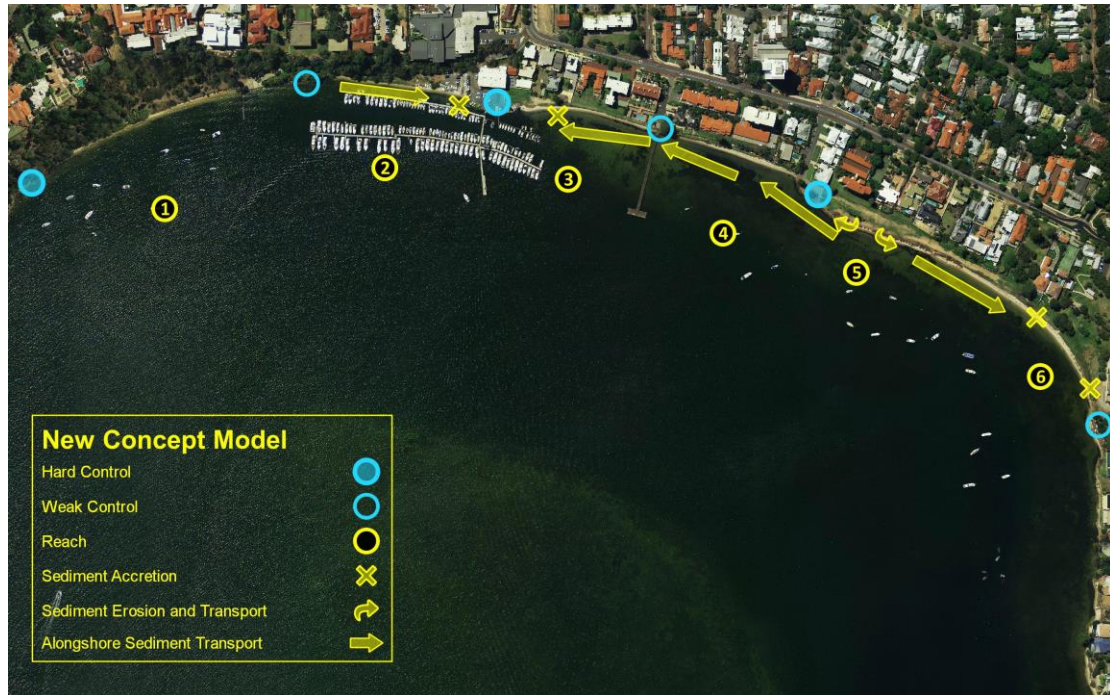
Figure 42: Conceptual model and foreshore reaches at Town of Claremont beaches

Foreshore dynamics within the Town of Claremont' beaches are consistent with a slow-moving bi-directional sediment transport due to locally generated wind waves. There are six distinct foreshore reaches (Figure 42), each of which is subject to a different orientation, profiles and structural control, affecting rates of sediment transport.

- Construction of the weak controls of Claremont Jetty and Claremont Baths caused the foreshore to evolve into a series of arcs (refer Figure 42), specifically between CYC and Claremont Jetty (Reach 3), Claremont Jetty and Chester Road (Reach 4) and Alex Prior Park and Watkins Road (Reach 6). Reach 5 is a protruding foreshore in the lee of Claremont Baths.

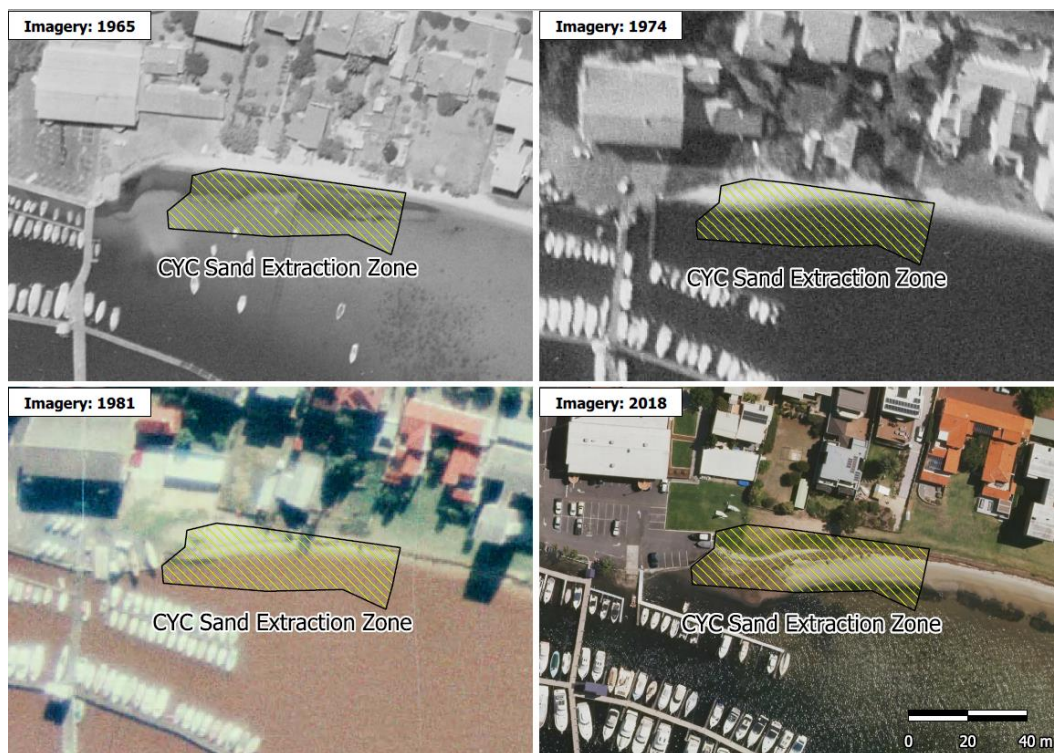
**Figure 43: Historic shoreline position comparison 1965 – 2018
Proposed sand extraction zone next to CYC**

The proposed extraction footprint will approximately reinstate the foreshore at this location to its 1974 shoreline position, as can be observed in the aerial imagery Figure 43. Note that this is still further riverward than the 1965 shoreline position, indicating that the historical riverbed will not be excavated. Neither indigenous nor European heritage artifacts will be disturbed during the sand extraction process.

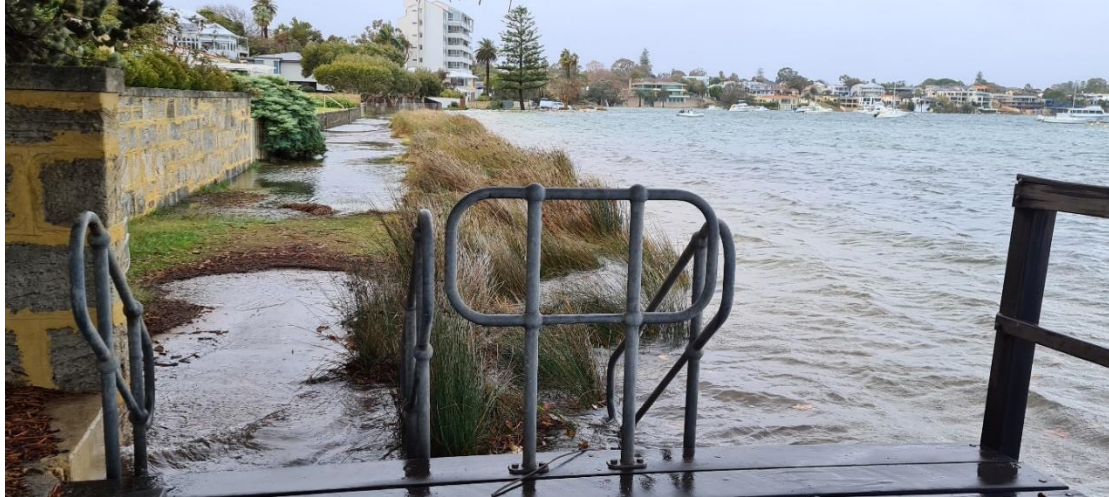
Figure 44: High water levels on 25 May 2020 - looking east from Claremont Jetty

Flooding of parts of Claremont foreshore occurred in May 2020, developed through the coincidence of high tide, a mid-latitude storm system and the remnants of ex-tropical cyclone Mangga. Photographs of the 25 May 2020 event have been supplied by DBCA and Town of Claremont.

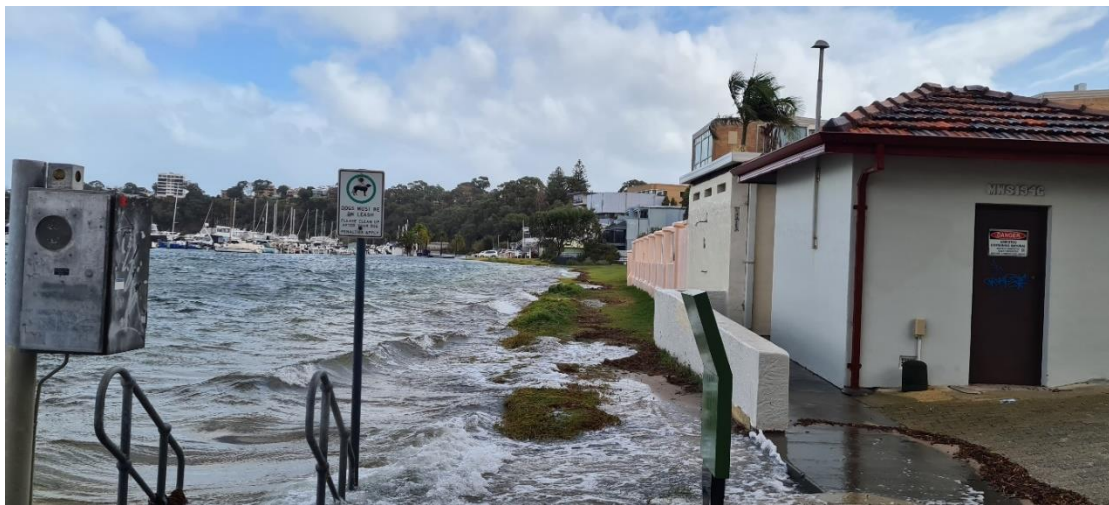
Figure 45: High water levels on 25 May 2020 - looking west from Claremont Jetty

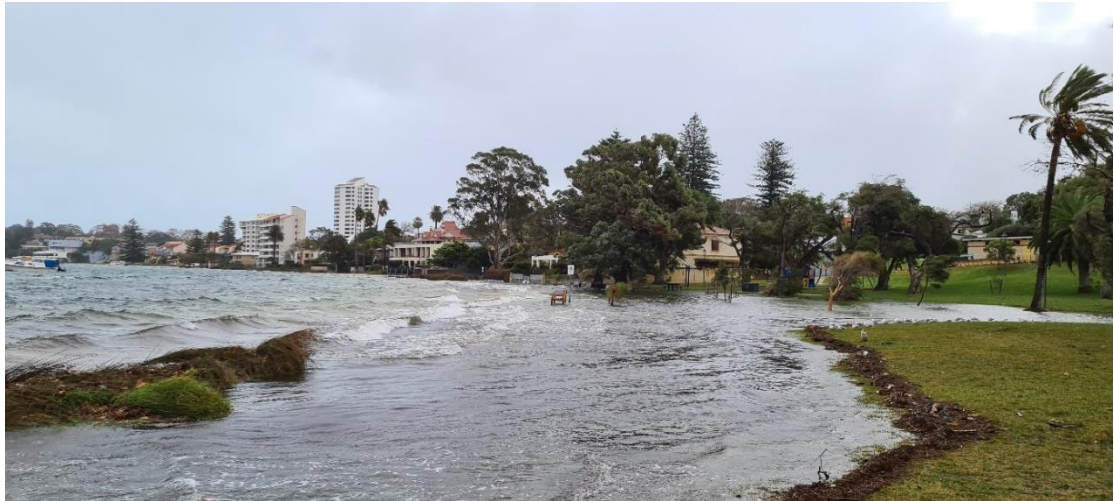
Figure 46: High water levels on 25 May 2020 - looking west from Mrs Herberts Park

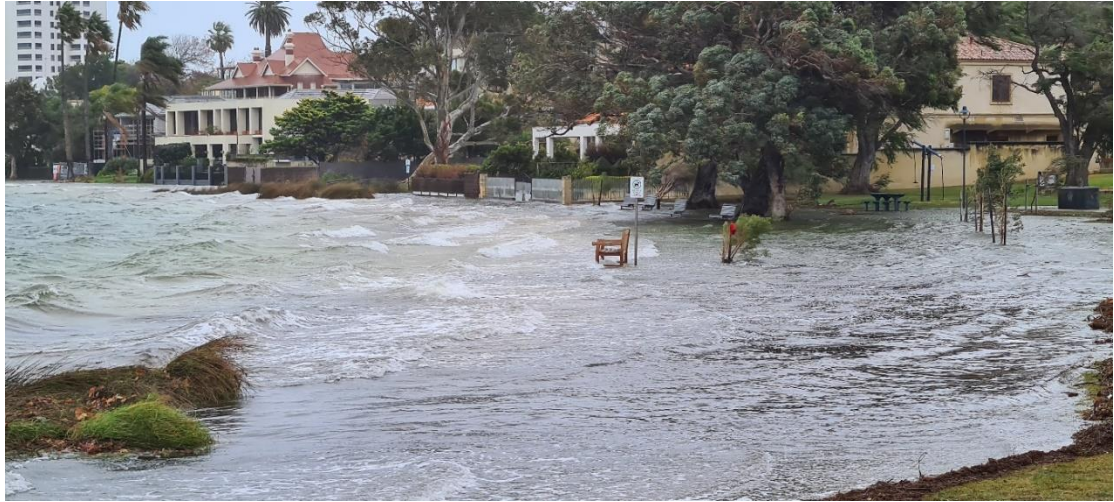
Figure 47: High water levels on 25 May 2020 - looking west across Mrs Herberts Park
